Access Compliance Report Public Rights-of-Way (Curb Ramps)

Intersection ID: 44421 Main Street: CENTRAL_AV Cross Street: ALBEMARLE_RD Location: NW

Overall Compliance: No ADA ID: E1F6D2A3B426 Ramp Type: Perp Initial Pass/Fail: Fail Severity Score: 33.75

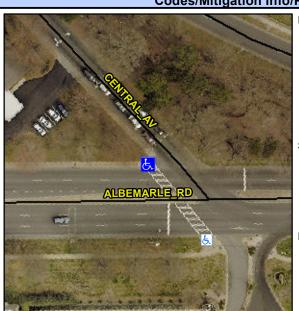
Field Measurements/Component Compliance							
Compliance Description		Data	Comp	liance Description	Data		
N/A	Ramp Length (in)	60.5	Yes	Ramp Slope (%)	5.1		
No	Ramp Width (in)	42.5	No	Ramp XSlope (%)	9.5		
N/A	Flare Type LT	N/A	N/A	Flare Type RT	N/A		
N/A	Flare Slope LT (%)	N/A	N/A	Flare Slope RT (%)	N/A		
N/A	Flare Traversable LT?	N/A	N/A	Flare Traversable RT?	N/A		
N/A	Landing Length (in)	N/A	N/A	DWS Provided?	N/A		
N/A	Landing Width (in)	N/A	N/A	DWS Contrast?	N/A		
N/A	Landing Slope (%)	N/A	N/A	DWS Length (in)	N/A		
N/A	Landing X Slope (%)	N/A	N/A	DWS Full Width?	N/A		
N/A	Landing Curb? (Y/N)	N/A	N/A	DWS Offset (in)	N/A		
N/A	Shared Landing?	N/A					
N/A	Gutter Ponding?	N/A	N/A	Gutter Slope (%)	N/A		
N/A	Gutter Lip Ht (in)	N/A	N/A	Gutter X Slope (%)	N/A		
N/A	Painted X Walk1?	Yes	N/A	Painted X Walk2?	N/A		
	X Walk 1 Direction	To SE		X Walk 2 Direction	N/A		
N/A	X Walk 1 Width (in)	110.0	N/A	X Walk 2 Width (in)	N/A

X Walk 1 Slope (%)	1.9		X Walk 2 Slope (%)	N/A		
	X Walk 1 X Slope (%)	4.9		X Walk 2 X Slope (%)	N/A		
N/A	Ramp inside XWalk1?	Yes	N/A	Ramp inside XWalk2?	N/A		
	Road Slope (%)	N/A	N/A	Clear Space?	N/A		
	Road X Slope (%)	N/A	N/A	Clear Space to XWalk (in)	N/A		
N/A	Any Obstructions?	N/A	N/A	Storm Grate/Utility Hazard?	N/A		
	Obstruction Type			Storm Grate/Utility Type			
		N/A			N/A		
			Yes	Surface Condition? (G/P)	Good		
	200

Possible Solutions:	<u>c</u>
Remove & Replace Entire Ramp.	N
	N
	N
	N
	N
	N
Surveyor Notes:	N
N/A	N
	N
	N
	N
PROW/ADA:	N
Not Found, R304.5.1, R304.5.3	N
	N
	N
	N
