Access Compliance Report Public Rights-of-Way (Curb Ramps)

Intersection ID: 7793 Main Street: JEFF ADAMS DR Cross Street: STATESVILLE_AV Location: SE **Overall Compliance: No** ADA ID: E1F6E0FFD597 Ramp Type: Perp Initial Pass/Fail: Fail **Severity Score:** 12.5

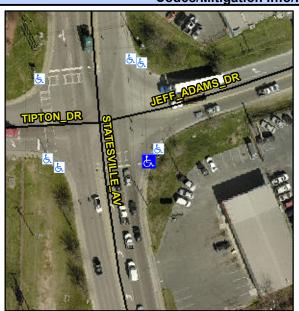
Comp	Compliance Description Data Compliance Description Data				
N/A	Ramp Length (in)	60.0	No	Ramp Slope (%)	9.6
Yes	Ramp Width (in)	48.0	Yes	Ramp XSlope (%)	0.1
N/A	Flare Type LT	N/A	N/A	Flare Type RT	N/A
N/A	Flare Slope LT (%)	N/A	N/A	Flare Slope RT (%)	N/A
N/A	Flare Traversable LT?	N/A	N/A	Flare Traversable RT?	N/A
N/A	Landing Length (in)	N/A	N/A	DWS Provided?	N/A
N/A	Landing Width (in)	N/A	N/A	DWS Contrast?	N/A
N/A	Landing Slope (%)	N/A	N/A	DWS Length (in)	N/A
N/A	Landing X Slope (%)	N/A	N/A	DWS Full Width?	N/A
N/A	Landing Curb? (Y/N)	N/A	N/A	DWS Offset (in)	N/A
N/A	Shared Landing?	N/A			
N/A	Gutter Ponding?	N/A	N/A	Gutter Slope (%)	N/A
N/A	Gutter Lip Ht (in)	N/A	N/A	Gutter X Slope (%)	N/A
N/A	Painted X Walk1?	Yes	N/A	Painted X Walk2?	N/A
	X Walk 1 Direction	To W		X Walk 2 Direction	N/A
N/A	X Walk 1 Width (in)	101.0	N/A	X Walk 2 Width (in)	N/A
	X Walk 1 Slope (%)	0.5		X Walk 2 Slope (%)	N/A
	X Walk 1 X Slope (%)	0.4		X Walk 2 X Slope (%)	N/A

N/A	Ramp inside XWalk1?	Yes	N/A	Ramp inside XWalk2?	N/A
	Road Slope (%)	N/A	N/A	Clear Space?	N/A
	Road X Slope (%)	N/A	N/A	Clear Space to XWalk (in)	N/A
N/A	Any Obstructions?	N/A	N/A	Storm Grate/Utility Hazard?	N/A
	Obstruction Type			Storm Grate/Utility Type	
		N/A			N/A
			Yes	Surface Condition? (G/P)	Good

Possible Solutions:	Cor
Remove & Replace Entire Ramp.	N/A
•	Yes
	N/A
	N/A
	N/A
	N/A
Surveyor Notes:	N/A
N/A	N/A
	N/A
	N/A
	N/A
PROW/ADA:	N/A
Not Found, R304.2.2	N/A
·	N/A
	N/A
	N/A
