Intersection ID: 17467	Main Street: CROYDON_RD	Cross Street: STERLING_RD	Location:	SE
ADA ID: E202C2EF6D19	Ramp Type: PerpDiag	Initial Pass/Fail: Fail	Overall Compliance: No	Severity Score: 13.75

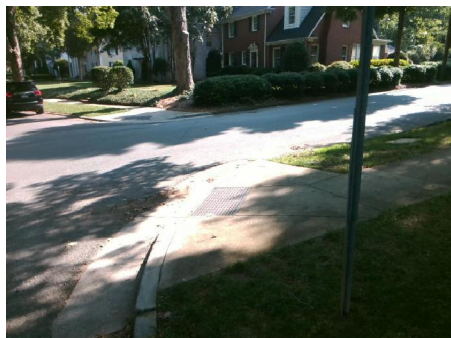
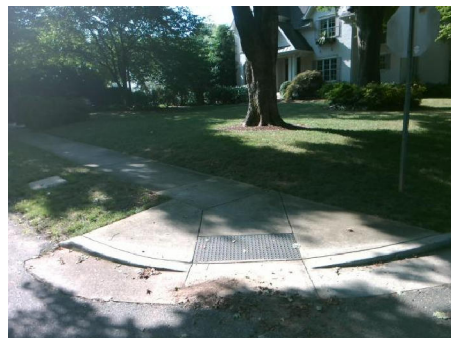
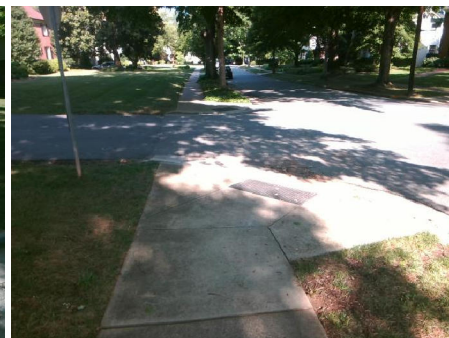
**Not Found, R304.2.2, R304.5.3**

Compliance	Description	Data	Compliance	Description	Data
N/A	Ramp Length (in)	60.5	No	Ramp Slope (%)	9.3
Yes	Ramp Width (in)	49.0	No	Ramp XSlope (%)	3.9
N/A	Flare Type LT	N/A	N/A	Flare Type RT	N/A
N/A	Flare Slope LT (%)	N/A	N/A	Flare Slope RT (%)	N/A
N/A	Flare Traversable LT?	N/A	N/A	Flare Traversable RT?	N/A
N/A	Landing Length (in)	N/A	N/A	DWS Provided?	N/A
N/A	Landing Width (in)	N/A	N/A	DWS Contrast?	N/A
N/A	Landing Slope (%)	N/A	N/A	DWS Length (in)	N/A
N/A	Landing X Slope (%)	N/A	N/A	DWS Full Width?	N/A
N/A	Landing Curb? (Y/N)	N/A	N/A	DWS Offset (in)	N/A
N/A	Shared Landing?	N/A			
N/A	Gutter Ponding?	N/A	N/A	Gutter Slope (%)	N/A
N/A	Gutter Lip Ht (in)	N/A	N/A	Gutter X Slope (%)	N/A
N/A	Painted X Walk1?	No	N/A	Painted X Walk2?	No
	X Walk 1 Direction	To NE		X Walk 2 Direction	To NW
N/A	X Walk 1 Width (in)	N/A	N/A	X Walk 2 Width (in)	N/A
	X Walk 1 Slope (%)	3.1		X Walk 2 Slope (%)	2.2
	X Walk 1 X Slope (%)	2.8		X Walk 2 X Slope (%)	0.7

N/A	Ramp inside XWalk1?	N/A	N/A	Ramp inside XWalk2?	N/A
	Road Slope (%)	0.4	N/A	Clear Space?	N/A
	Road X Slope (%)	1.6	N/A	Clear Space to XWalk (in)	N/A
N/A	Any Obstructions?	N/A	N/A	Storm Grate/Utility Hazard?	N/A
	Obstruction Type			Storm Grate/Utility Type	
		N/A			N/A
			Yes	Surface Condition? (G/P)	Good

**Remove & Replace Curb Ramp With Two New Directional Ramps or Equivalent.**
