# Access Compliance Report

## Public Rights-of-Way

### (Curb Ramps)

Intersection ID: 5868	Main Street: PIMPERNEL_RD	Cross Street: PARTRIDGEBERRY_DR	Location: NW
ADA ID: E2085987A3DF	Ramp Type: Perp	Initial Pass/Fail: Fail	Overall Compliance: No
Severity Score: 12.5			
Codes/Mitigation Info/Possible Solution		Field Measurements/Component Compliance

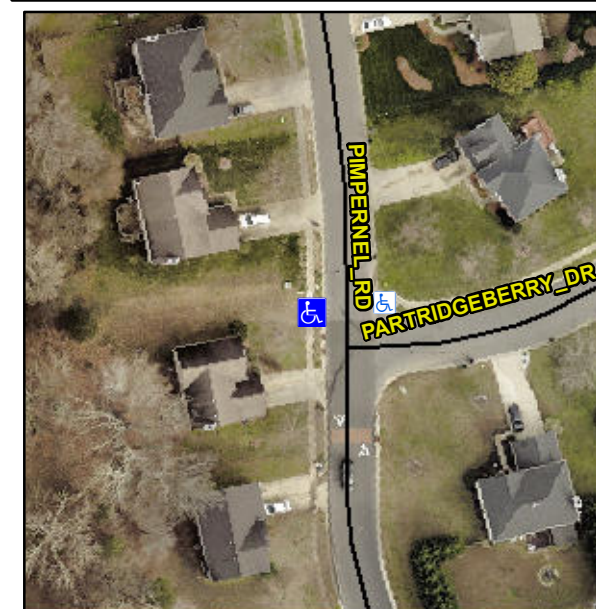
Compliance	Description	Data	Compliance	Description	Data
N/A	Ramp Length (in)	47.0	No	Ramp Slope (%)	11.1
Yes	Ramp Width (in)	68.1	Yes	Ramp XSlope (%)	0.3
N/A	Flare Type LT	N/A	N/A	Flare Type RT	N/A
N/A	Flare Slope LT (%)	N/A	N/A	Flare Slope RT (%)	N/A
N/A	Flare Traversable LT?	N/A	N/A	Flare Traversable RT?	N/A
N/A	Landing Length (in)	N/A	N/A	DWS Provided?	N/A
N/A	Landing Width (in)	N/A	N/A	DWS Contrast?	N/A
N/A	Landing Slope (%)	N/A	N/A	DWS Length (in)	N/A
N/A	Landing X Slope (%)	N/A	N/A	DWS Full Width?	N/A
N/A	Landing Curb? (Y/N)	N/A	N/A	DWS Offset (in)	N/A
N/A	Shared Landing?	N/A			
N/A	Gutter Ponding?	N/A	N/A	Gutter Slope (%)	N/A
N/A	Gutter Lip Ht (in)	N/A	N/A	Gutter X Slope (%)	N/A
N/A	Painted X Walk1?	No	N/A	Painted X Walk2?	N/A
	X Walk 1 Direction	To E		X Walk 2 Direction	N/A
N/A	X Walk 1 Width (in)	N/A	N/A	X Walk 2 Width (in)	N/A
	X Walk 1 Slope (%)	8.2		X Walk 2 Slope (%)	N/A
	X Walk 1 X Slope (%)	0.0		X Walk 2 X Slope (%)	N/A

N/A	Ramp inside XWalk1?	N/A	N/A	Ramp inside XWalk2?	N/A
	Road Slope (%)	N/A	N/A	Clear Space?	N/A
	Road X Slope (%)	N/A	N/A	Clear Space to XWalk (in)	N/A
N/A	Any Obstructions?	N/A	N/A	Storm Grate/Utility Hazard?	N/A
	Obstruction Type			Storm Grate/Utility Type	
		N/A			N/A
			Yes	Surface Condition? (G/P)	Good

Possible Solutions:

**Remove & Replace Entire Ramp.**

Total Cost: \$ 1850.00
