# Access Compliance Report

## Public Rights-of-Way

### (Curb Ramps)

Intersection ID: 17138	Main Street: IDLEWILD_RD	Cross Street: PINEY GROVE_RD	Location: NW
ADA ID: E229DA52D407	Ramp Type: Para	Initial Pass/Fail: Fail	Overall Compliance: No
			Severity Score: 13.75

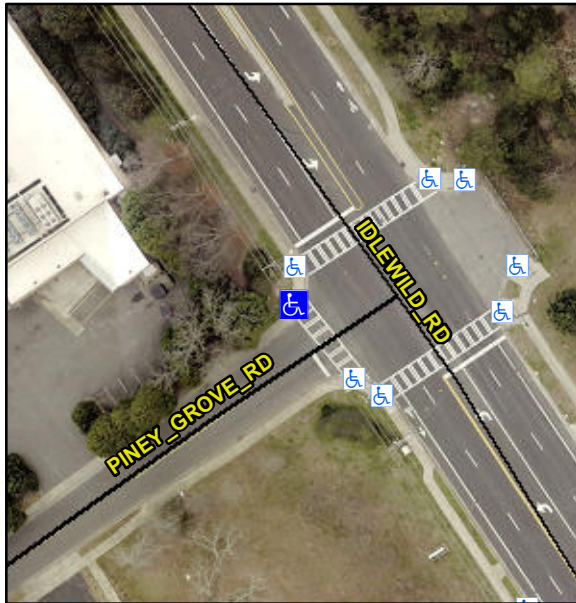
**LT RP < 5%**

Compliance	Description	Data	Compliance	Description	Data
N/A	Ramp Length LT (in)	81.0	N/A	Ramp Length RT (in)	87.0
Yes	Ramp Width LT (in)	48.5	Yes	Ramp Width RT (in)	60.0
Yes	Ramp Slope LT (%)	2.7	No	Ramp Slope RT (%)	8.8
No	Ramp XSlope LT (%)	2.1	Yes	Ramp XSlope RT (%)	1.0
N/A	Landing Length (in)	N/A	N/A	DWS Provided?	N/A
N/A	Landing Width (in)	N/A	N/A	DWS Contrast?	N/A
N/A	Landing Slope (%)	N/A	N/A	DWS Length (in)	N/A
N/A	Landing X Slope (%)	N/A	N/A	DWS Full Width?	N/A
N/A	Landing Curb? (Y/N)	N/A	N/A	DWS Offset (in)	N/A
N/A	Shared Landing?	N/A			
N/A	Gutter Ponding?	N/A	N/A	Gutter Slope (%)	N/A
N/A	Gutter Lip Ht (in)	N/A	N/A	Gutter X Slope (%)	N/A
N/A	Painted X Walk1?	Yes	N/A	Painted X Walk2?	N/A
	X Walk 1 Direction	To SE		X Walk 2 Direction	N/A
N/A	X Walk 1 Width (in)	110.0	N/A	X Walk 2 Width (in)	N/A
	X Walk 1 Slope (%)	3.6		X Walk 2 Slope (%)	N/A
	X Walk 1 X Slope (%)	3.0		X Walk 2 X Slope (%)	N/A
N/A	Ramp inside XWalk1?	Yes	N/A	Ramp inside XWalk2?	N/A

Possible Solutions:

**Remove & Replace Entire Ramp.**
