Access Compliance Report Public Rights-of-Way (Curb Ramps)

Intersection ID: 48492 Main Street: SHOPTON RD WEST Cross Street: BEREWICK COMMONS PY Location: SW **Severity Score:** 10 **ADA ID: E22DC2533CC1** Ramp Type: Perp Initial Pass/Fail: Fail **Overall Compliance: No**

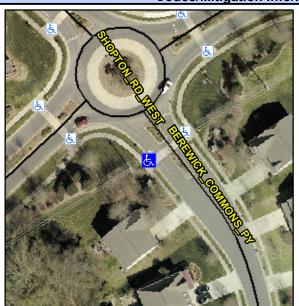
BEREWICK COMMONS PY Street 1 Name Stop Condition-Street 2 YieldSign N/A Street 2 Name Stop Condition-Street 1 N/A Possible Solutions: Compliance Description N/A Remove & Replace Entire Ramp. No N/A Surveyor Notes: N/A PROW/ADA: Not Found, R304.5.1, R304.5.3
