Access Compliance Report

Public Rights-of-Way

(Curb Ramps)

Intersection ID: 27298	Main Street: CHARTER_HILLS_RD	Cross Street: OWL_NEST_LN	Location: SE
ADA ID: E23EE8EA7F8A	Ramp Type: PerpDiag	Initial Pass/Fail: Fail	Overall Compliance: No
Severity Score: 21.25			
Codes/Mitigation Info/Possible Solution		Field Measurements/Component Compliance

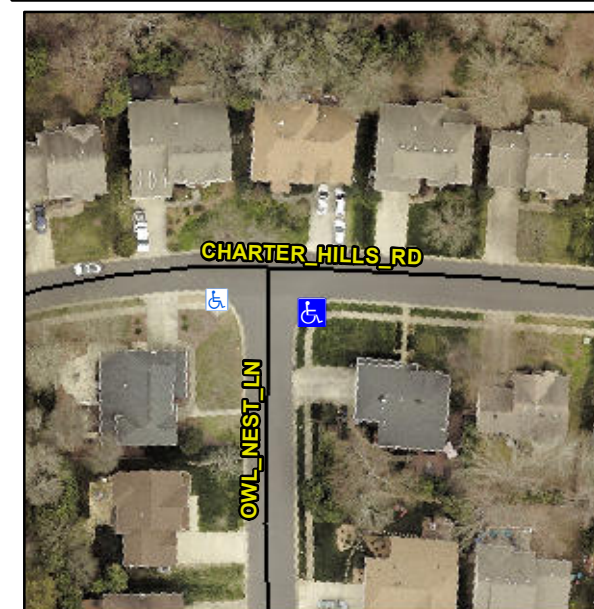
Not Found, R304.5.1, R304.5.3

Compliance	Description	Data	Compliance	Description	Data
N/A	Ramp Length (in)	40.0	Yes	Ramp Slope (%)	5.2
No	Ramp Width (in)	46.5	No	Ramp XSlope (%)	5.9
N/A	Flare Type LT	N/A	N/A	Flare Type RT	N/A
N/A	Flare Slope LT (%)	N/A	N/A	Flare Slope RT (%)	N/A
N/A	Flare Traversable LT?	N/A	N/A	Flare Traversable RT?	N/A
N/A	Landing Length (in)	N/A	N/A	DWS Provided?	N/A
N/A	Landing Width (in)	N/A	N/A	DWS Contrast?	N/A
N/A	Landing Slope (%)	N/A	N/A	DWS Length (in)	N/A
N/A	Landing X Slope (%)	N/A	N/A	DWS Full Width?	N/A
N/A	Landing Curb? (Y/N)	N/A	N/A	DWS Offset (in)	N/A
N/A	Shared Landing?	N/A			
N/A	Gutter Ponding?	N/A	N/A	Gutter Slope (%)	N/A
N/A	Gutter Lip Ht (in)	N/A	N/A	Gutter X Slope (%)	N/A
N/A	Painted X Walk1?	No	N/A	Painted X Walk2?	No
	X Walk 1 Direction	To N		X Walk 2 Direction	To NW
N/A	X Walk 1 Width (in)	N/A	N/A	X Walk 2 Width (in)	N/A
	X Walk 1 Slope (%)	4.5		X Walk 2 Slope (%)	0.7
	X Walk 1 X Slope (%)	0.3		X Walk 2 X Slope (%)	8.2

N/A	Ramp inside XWalk1?	N/A	N/A	Ramp inside XWalk2?	N/A
	Road Slope (%)	4.7	N/A	Clear Space?	N/A
	Road X Slope (%)	3.3	N/A	Clear Space to XWalk (in)	N/A
N/A	Any Obstructions?	N/A	N/A	Storm Grate/Utility Hazard?	N/A
	Obstruction Type			Storm Grate/Utility Type	
		N/A			N/A
		Yes		Surface Condition? (G/P)	Good

Possible Solutions:

Remove & Replace Curb Ramp With Two New Directional Ramps or Equivalent.
