Access Compliance Report

Public Rights-of-Way

(Curb Ramps)

| Intersection ID: 10622 | Main Street: MULBERRY_CHURCH_RD | Cross Street: N/A | Location: NW |

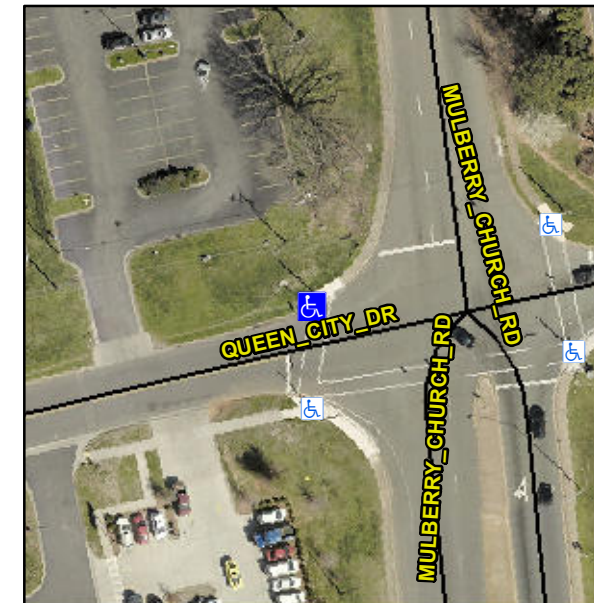
| ADA ID: E243183CD65B | Ramp Type: Perp | Initial Pass/Fail: Fail | Overall Compliance: No |
| | | | Severity Score: 21.25 |

R304.5.1, R304.2.2

| Compliance | Description | Data | Compliance | Description | Data |
|---|---|---|---|---|---|
| N/A | Ramp Length (in) | 60.0 | No | Ramp Slope (%) | 8.4 |
| No | Ramp Width (in) | 43.0 | Yes | Ramp XSlope (%) | 1.3 |

Possible Solutions:

Remove & Replace Entire Ramp.

Total Cost: \$ 1850.00
