Access Compliance Report

Public Rights-of-Way

(Curb Ramps)

| Intersection ID: 27178 | Main Street: MCKEE_RD | Cross Street: SIKES_PL | Location: SE |

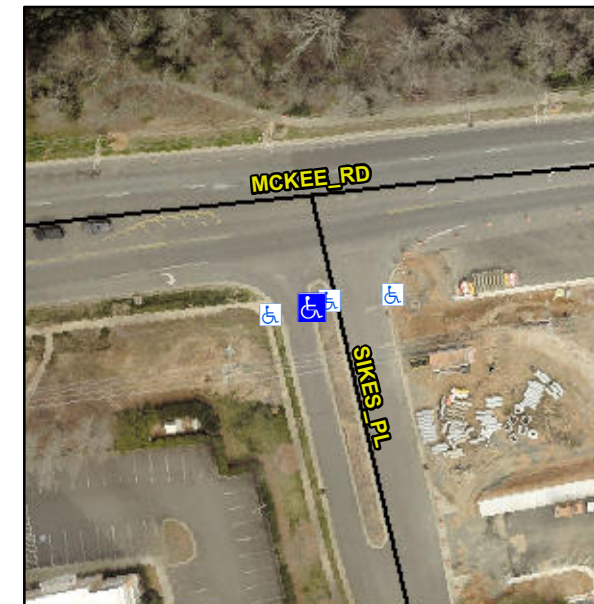
| ADA ID: E2434F130992 | Ramp Type: Perp | Initial Pass/Fail: Fail | Overall Compliance: No |
| | | Severity Score: 12.5 | |

R304.2.2

| Compliance | Description | Data | Compliance | Description | Data |
|---|---|---|---|---|---|
| N/A | Ramp Length (in) | 49.0 | No | Ramp Slope (%) | 9.9 |

Remove & Replace Entire Ramp.

\$ 1850.00
