Access Compliance Report

Public Rights-of-Way

(Curb Ramps)

| Intersection ID: 50446 | Main Street: ALICE_MCGINN_DR | Cross Street: HAWFIELD_WOODS_LN | Location: SE |

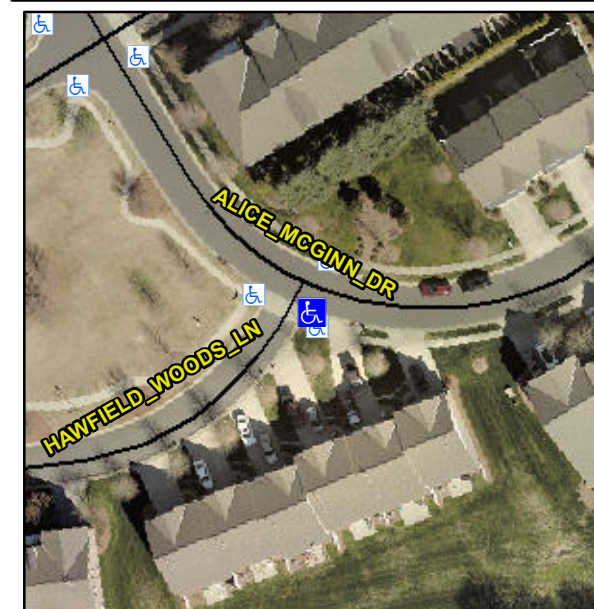
| ADA ID: E24451FDDF72 | Ramp Type: Perp | Initial Pass/Fail: Fail | Overall Compliance: No |
| Severity Score: 12.5 | | | |

Not Found, R304.5.3

| Compliance | Description | Data | Compliance | Description | Data |
|---|---|---|---|---|---|
| Yes | Ramp Width (in) | 48.0 | No | Ramp XSlope (%) | 5.4 |

Remove & Replace Entire Ramp.
