Intersection ID: 12493	Main Street: BELVEDERE_AV	Cross Street: WINTER_ST	Location:	SW
ADA ID: E24D4D09BA81	Ramp Type: Perp	Initial Pass/Fail: Fail	Overall Compliance: No	Severity Score: 21.25

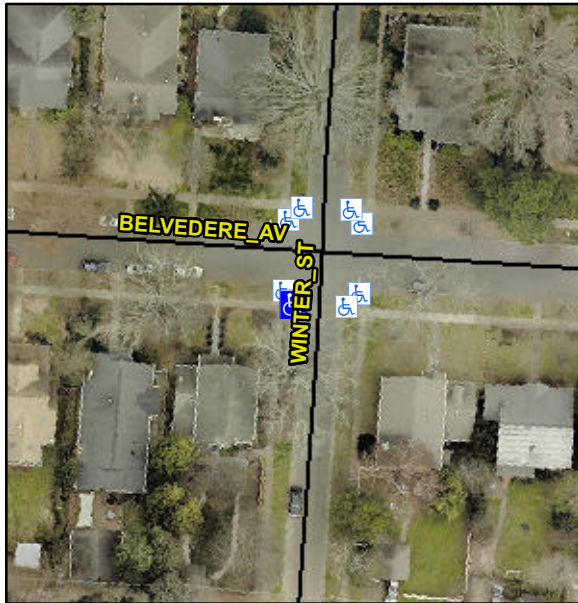
**Not Found, R304.5.1, R304.2.2**

Compliance	Description	Data	Compliance	Description	Data
N/A	Ramp Length (in)	91.0	No	Ramp Slope (%)	8.4
No	Ramp Width (in)	43.0	Yes	Ramp XSlope (%)	0.2
N/A	Flare Type LT	N/A	N/A	Flare Type RT	N/A
N/A	Flare Slope LT (%)	N/A	N/A	Flare Slope RT (%)	N/A
N/A	Flare Traversable LT?	N/A	N/A	Flare Traversable RT?	N/A
N/A	Landing Length (in)	N/A	N/A	DWS Provided?	N/A
N/A	Landing Width (in)	N/A	N/A	DWS Contrast?	N/A
N/A	Landing Slope (%)	N/A	N/A	DWS Length (in)	N/A
N/A	Landing X Slope (%)	N/A	N/A	DWS Full Width?	N/A
N/A	Landing Curb? (Y/N)	N/A	N/A	DWS Offset (in)	N/A
N/A	Shared Landing?	N/A			
N/A	Gutter Ponding?	N/A	N/A	Gutter Slope (%)	N/A
N/A	Gutter Lip Ht (in)	N/A	N/A	Gutter X Slope (%)	N/A
N/A	Painted X Walk1?	No	N/A	Painted X Walk2?	N/A
	X Walk 1 Direction	To E		X Walk 2 Direction	N/A
N/A	X Walk 1 Width (in)	N/A	N/A	X Walk 2 Width (in)	N/A
	X Walk 1 Slope (%)	0.5		X Walk 2 Slope (%)	N/A
	X Walk 1 X Slope (%)	0.2		X Walk 2 X Slope (%)	N/A

N/A	Ramp inside XWalk1?	N/A	N/A	Ramp inside XWalk2?	N/A
	Road Slope (%)	N/A	N/A	Clear Space?	N/A
	Road X Slope (%)	N/A	N/A	Clear Space to XWalk (in)	N/A
N/A	Any Obstructions?	N/A	N/A	Storm Grate/Utility Hazard?	N/A
	Obstruction Type			Storm Grate/Utility Type	
		N/A			N/A
			Yes	Surface Condition? (G/P)	Good

### Remove & Replace Entire Ramp.
