## Access Compliance Report Public Rights-of-Way (Curb Ramps)

Intersection ID: 28245 Main Street: SOCIETY\_ST Cross Street: COMMUNITY\_HOUSE\_RD Location: SW

ADA ID: E28870D2ED73 Ramp Type: PerpDiag Initial Pass/Fail: Fail Overall Compliance: No Severity Score: 31.25

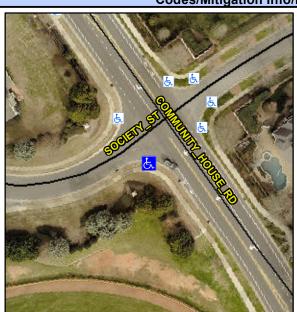
Field Measurements/Component Compnance							
	Compliance Description		Data	Com	oliance Description	Data	
	N/A	Ramp Length (in)	64.0	No	Ramp Slope (%)	8.4	
	No	Ramp Width (in)	35.0	No	Ramp XSlope (%)	2.8	
	N/A	Flare Type LT	N/A	N/A	Flare Type RT	N/A	
	N/A	Flare Slope LT (%)	N/A	N/A	Flare Slope RT (%)	N/A	
	N/A	Flare Traversable LT?	N/A	N/A	Flare Traversable RT?	N/A	
	N/A	Landing Length (in)	N/A	N/A	DWS Provided?	N/A	
	N/A	Landing Width (in)	N/A	N/A	DWS Contrast?	N/A	
	N/A	Landing Slope (%)	N/A	N/A	DWS Length (in)	N/A	
	N/A	Landing X Slope (%)	N/A	N/A	DWS Full Width?	N/A	
	N/A	Landing Curb? (Y/N)	N/A	N/A	DWS Offset (in)	N/A	
	N/A	Shared Landing?	N/A				
	N/A	Gutter Ponding?	N/A	N/A	Gutter Slope (%)	N/A	
	N/A	Gutter Lip Ht (in)	N/A	N/A	Gutter X Slope (%)	N/A	
	N/A	Painted X Walk1?	No	N/A	Painted X Walk2?	No	
		X Walk 1 Direction	To NE		X Walk 2 Direction	To NW	
	N/A	X Walk 1 Width (in)	N/A	N/A	X Walk 2 Width (in)	N/A

X Walk 1 Slope (%)	1.6		X Walk 2 Slope (%)	0.5	
		X Walk 1 X Slope (%)	0.5		X Walk 2 X Slope (%)	1.3	
	N/A	Ramp inside XWalk1?	N/A	N/A	Ramp inside XWalk2?	N/A	
		Road Slope (%)	1.7	N/A	Clear Space?	N/A	
		Road X Slope (%)	2.0	N/A	Clear Space to XWalk (in)	N/A	
	N/A	Any Obstructions?	N/A	N/A	Storm Grate/Utility Hazard?	N/A	
		Obstruction Type			Storm Grate/Utility Type		
			N/A			N/A	
				Yes	Surface Condition? (G/P)	Good	
	_			-

Remove & Replace Curb Ramp With Two New Directional Ramps or Equivalent.

Total Cost: \$ 3200.0
