# Access Compliance Report

## Public Rights-of-Way

### (Curb Ramps)

Intersection ID: 6475	Main Street: CAPPS_HILL_MINE_RD	Cross Street: FIRESTONE_DR	Location: S
ADA ID: E28D9F9F5FDB	Ramp Type: Perp	Initial Pass/Fail: Fail	Overall Compliance: No
Codes/Mitigation Info/Possible Solution		Field Measurements/Component Compliance	
Severity Score: 21.25

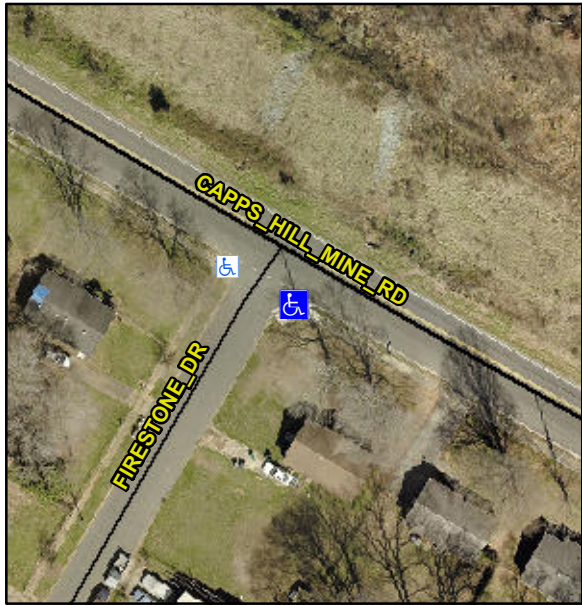
Compliance		Description	Data	Compliance	Description	Data
N/A	Ramp Length (in)	49.0	No	Ramp Slope (%)	9.7	
No	Ramp Width (in)	46.5	Yes	Ramp XSlope (%)	2.0	
N/A	Flare Type LT	N/A	N/A	Flare Type RT	N/A	
N/A	Flare Slope LT (%)	N/A	N/A	Flare Slope RT (%)	N/A	
N/A	Flare Traversable LT?	N/A	N/A	Flare Traversable RT?	N/A	
N/A	Landing Length (in)	N/A	N/A	DWS Provided?	N/A	
N/A	Landing Width (in)	N/A	N/A	DWS Contrast?	N/A	
N/A	Landing Slope (%)	N/A	N/A	DWS Length (in)	N/A	
N/A	Landing X Slope (%)	N/A	N/A	DWS Full Width?	N/A	
N/A	Landing Curb? (Y/N)	N/A	N/A	DWS Offset (in)	N/A	
N/A	Shared Landing?	N/A				
N/A	Gutter Ponding?	N/A	N/A	Gutter Slope (%)	N/A	
N/A	Gutter Lip Ht (in)	2.0	N/A	Gutter X Slope (%)	N/A	
N/A	Painted X Walk1?	No	N/A	Painted X Walk2?	N/A	
	X Walk 1 Direction	To NW		X Walk 2 Direction	N/A	
N/A	X Walk 1 Width (in)	N/A	N/A	X Walk 2 Width (in)	N/A	
	X Walk 1 Slope (%)	1.3		X Walk 2 Slope (%)	N/A	
	X Walk 1 X Slope (%)	1.4		X Walk 2 X Slope (%)	N/A

N/A	Ramp inside XWalk1?	N/A	N/A	Ramp inside XWalk2?	N/A	
	Road Slope (%)	N/A	N/A	Clear Space?	N/A	
	Road X Slope (%)	N/A	N/A	Clear Space to XWalk (in)	N/A	
N/A	Any Obstructions?	N/A	N/A	Storm Grate/Utility Hazard?	N/A	
	Obstruction Type			Storm Grate/Utility Type		
		N/A			N/A	
			Yes	Surface Condition? (G/P)	Good

Remove & Replace Entire Ramp.

Not Found, R304.5.1, R304.2.2
