Access Compliance Report

Public Rights-of-Way

(Curb Ramps)

Intersection ID: N/A	Main Street: WENDOVER_RD	Cross Street: N/A	Location: NW
ADA ID: E2C178C60515	Ramp Type: PerpDiag	Initial Pass/Fail: Fail	Overall Compliance: No
Severity Score: 33.75			
Codes/Mitigation Info/Possible Solution		Field Measurements/Component Compliance

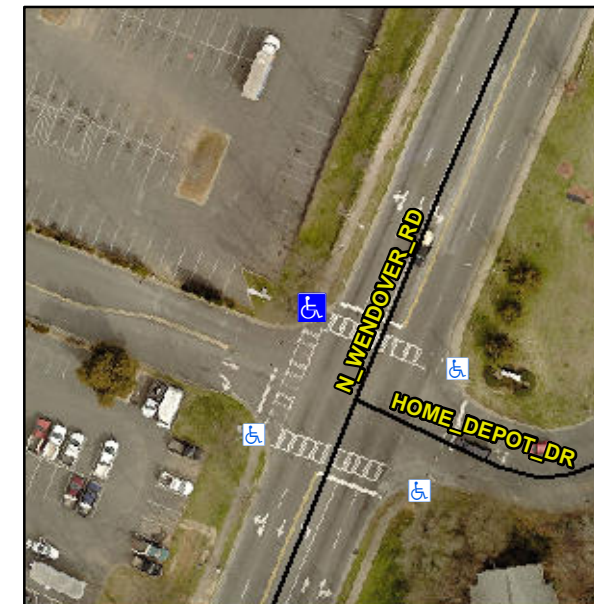
Not Found, R304.5.1, R304.5.3

Compliance	Description	Data	Compliance	Description	Data
N/A	Ramp Length (in)	82.0	Yes	Ramp Slope (%)	5.2
No	Ramp Width (in)	46.0	No	Ramp XSlope (%)	8.8
N/A	Flare Type LT	N/A	N/A	Flare Type RT	N/A
N/A	Flare Slope LT (%)	N/A	N/A	Flare Slope RT (%)	N/A
N/A	Flare Traversable LT?	N/A	N/A	Flare Traversable RT?	N/A
N/A	Landing Length (in)	N/A	N/A	DWS Provided?	N/A
N/A	Landing Width (in)	N/A	N/A	DWS Contrast?	N/A
N/A	Landing Slope (%)	N/A	N/A	DWS Length (in)	N/A
N/A	Landing X Slope (%)	N/A	N/A	DWS Full Width?	N/A
N/A	Landing Curb? (Y/N)	N/A	N/A	DWS Offset (in)	N/A
N/A	Shared Landing?	N/A			
N/A	Gutter Ponding?	N/A	N/A	Gutter Slope (%)	N/A
N/A	Gutter Lip Ht (in)	N/A	N/A	Gutter X Slope (%)	N/A
N/A	Painted X Walk1?	Yes	N/A	Painted X Walk2?	Yes
	X Walk 1 Direction	To SW		X Walk 2 Direction	To SE
N/A	X Walk 1 Width (in)	95.0	N/A	X Walk 2 Width (in)	98.0
	X Walk 1 Slope (%)	4.3		X Walk 2 Slope (%)	0.6
	X Walk 1 X Slope (%)	2.0		X Walk 2 X Slope (%)	4.2

N/A	Ramp inside XWalk1?	Yes	N/A	Ramp inside XWalk2?	Yes
	Road Slope (%)	3.0	N/A	Clear Space?	N/A
	Road X Slope (%)	0.6	N/A	Clear Space to XWalk (in)	N/A
N/A	Any Obstructions?	N/A	N/A	Storm Grate/Utility Hazard?	N/A
	Obstruction Type			Storm Grate/Utility Type	
		N/A			N/A
		Yes		Surface Condition? (G/P)	Good

Possible Solutions:

Remove & Replace Curb Ramp With Two New Directional Ramps or Equivalent.

Total Cost: \$ 3200.00
