Access Compliance Report

Public Rights-of-Way

(Curb Ramps)

| Intersection ID: 14466 | Main Street: W_TYVOLA_RD | Cross Street: RICHARD_ST | Location: S |

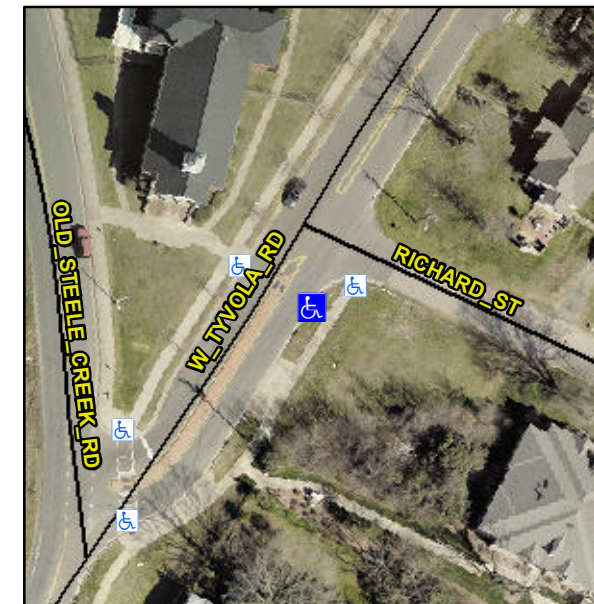
| ADA ID: E2CFA3666B41 | Ramp Type: Perp | Initial Pass/Fail: Fail | Overall Compliance: No |
| Severity Score: 13.75 | | | |

Not Found, R304.2.2, R304.5.3

| Compliance | Description | Data | Compliance | Description | Data |
|---|---|---|---|---|---|
| N/A | Ramp Length (in) | 99.0 | No | Ramp Slope (%) | 10.1 |
| Yes | Ramp Width (in) | 59.0 | No | Ramp XSlope (%) | 4.9 |

Remove & Replace Entire Ramp.

Total Cost: \$ 1850.00
