Access Compliance Report

Public Rights-of-Way

(Curb Ramps)

Intersection ID: 43934	Main Street: ALBEMARLE_RD	Cross Street: CIRCUMFERENTIAL_RD	Location: SE
ADA ID: E2E4CAD0BEA3	Ramp Type: BlendTrans1	Initial Pass/Fail: Fail	Overall Compliance: No
		Severity Score: 10

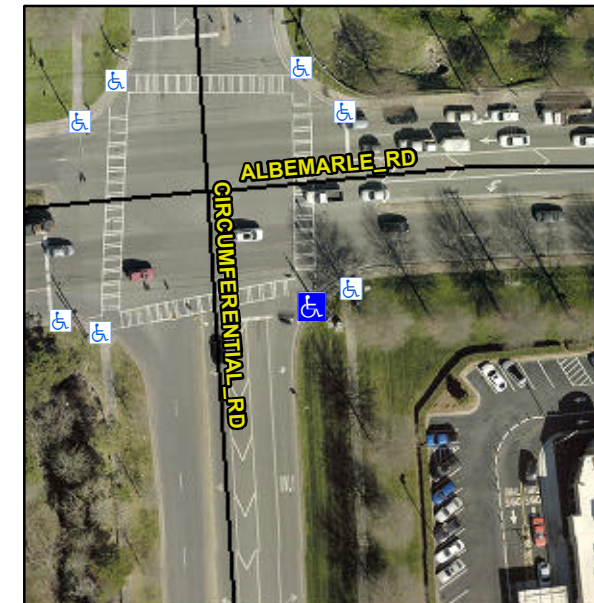
Not Found, R304.5.1, R304.5.3

Compliance	Description	Data	Compliance	Description	Data
N/A	Ramp Length (in)	62.0	Yes	BlendTrans Slope (%)	3.7
No	Ramp Width (in)	46.0	No	BlendTrans XSlope (%)	3.5
N/A	Flare Type LT	N/A	N/A	Flare Type RT	N/A
N/A	Flare Slope LT (%)	N/A	N/A	Flare Slope RT (%)	N/A
N/A	Flare Traversable LT?	N/A	N/A	Flare Traversable RT?	N/A
N/A	Landing Length (in)	N/A	N/A	DWS Provided?	N/A
N/A	Landing Width (in)	N/A	N/A	DWS Contrast?	N/A
N/A	Landing Slope (%)	N/A	N/A	DWS Length (in)	N/A
N/A	Landing X Slope (%)	N/A	N/A	DWS Full Width?	N/A
N/A	Landing Curb? (Y/N)	N/A	N/A	DWS Offset (in)	N/A
N/A	Shared Landing?	N/A			
N/A	Gutter Ponding?	N/A	N/A	Gutter Slope (%)	N/A
N/A	Gutter Lip Ht (in)	N/A	N/A	Gutter X Slope (%)	N/A
N/A	Painted X Walk1?	Yes	N/A	Painted X Walk2?	Yes
	X Walk 1 Direction	To N		X Walk 2 Direction	To W
	X Walk 1 Width (in)	115.0		X Walk 2 Width (in)	87.0
	X Walk 1 Slope (%)	5.1		X Walk 2 Slope (%)	1.9
	X Walk 1 X Slope (%)	1.4		X Walk 2 X Slope (%)	4.1

N/A	Ramp inside XWalk1?	Yes	N/A	Ramp inside XWalk2?	Yes
	Road Slope (%)	1.1		Clear Space?	N/A
	Road X Slope (%)	4.8	N/A	Clear Space to XWalk (in)	N/A
N/A	Any Obstructions?	N/A	N/A	Storm Grate/Utility Hazard?	N/A
	Obstruction Type			Storm Grate/Utility Type	
		N/A			N/A
		Yes		Surface Condition? (G/P)	Good
		No		Curb Slope (%)	6.7

Remove & Replace Curb Ramp With Two New Directional Ramps or Equivalent.
