# Access Compliance Report

## Public Rights-of-Way

### (Curb Ramps)

Intersection ID: 13882	Main Street: BARCLIFF_DR	Cross Street: FARM_POND_LN	Location: S
ADA ID: E2FC06330D44	Ramp Type: Perp	Initial Pass/Fail: Fail	Overall Compliance: No
Codes/Mitigation Info/Possible Solution		Field Measurements/Component Compliance	
Severity Score: 21.25

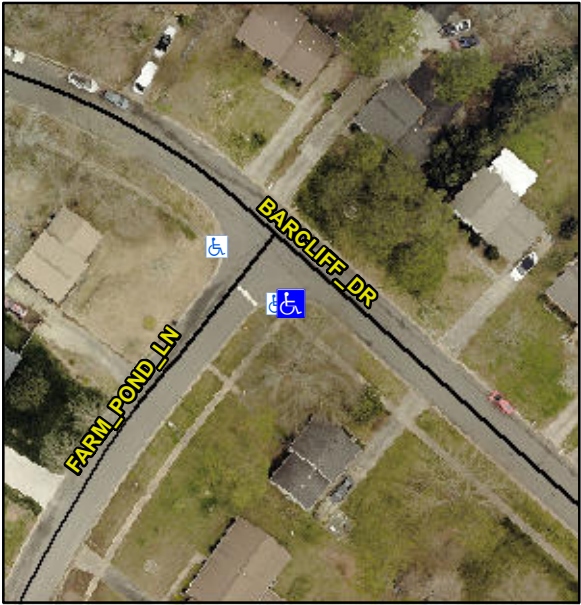
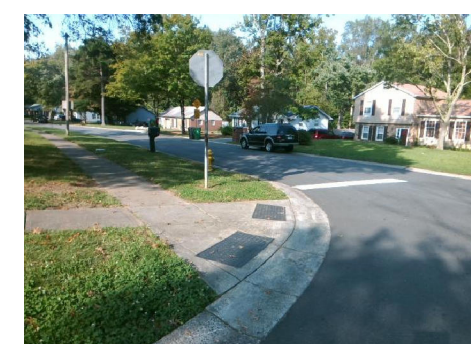
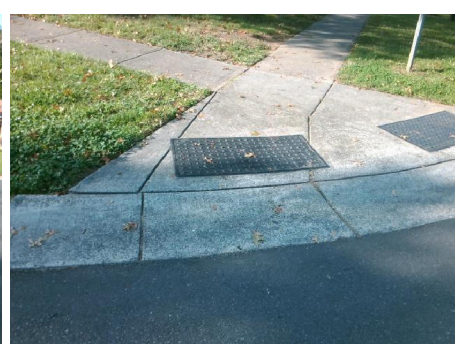
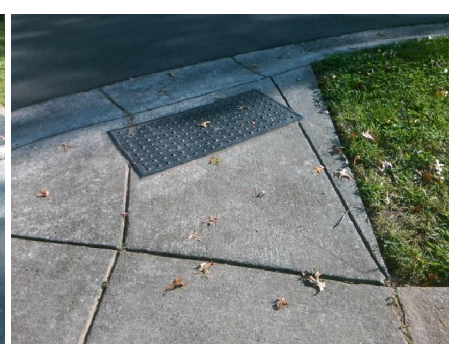
Possible Solutions:						
	Remove & Replace Entire Ramp.						
	Surveyor Notes:						
	N/A						
	PROW/ADA:						
	Not Found, R304.5.1, R304.5.3						
Street 1 Name	BARCLIFF DR	Compliance	Description	Data	Compliance	Description	Data
Stop Condition-Street 2	None	N/A	Ramp Length (in)	51.5	Yes	Ramp Slope (%)	5.5
Street 2 Name	N/A	No	Ramp Width (in)	44.0	No	Ramp XSlope (%)	6.1
Stop Condition-Street 1	N/A	N/A	Flare Type LT	N/A	N/A	Flare Type RT	N/A
		N/A	Flare Slope LT (%)	N/A	N/A	Flare Slope RT (%)	N/A
		N/A	Flare Traversable LT?	N/A	N/A	Flare Traversable RT?	N/A
		N/A	Landing Length (in)	N/A	N/A	DWS Provided?	N/A
		N/A	Landing Width (in)	N/A	N/A	DWS Contrast?	N/A
		N/A	Landing Slope (%)	N/A	N/A	DWS Length (in)	N/A
		N/A	Landing X Slope (%)	N/A	N/A	DWS Full Width?	N/A
		N/A	Landing Curb? (Y/N)	N/A	N/A	DWS Offset (in)	N/A
		N/A	Shared Landing?	N/A			
		N/A	Gutter Ponding?	N/A	N/A	Gutter Slope (%)	N/A
		N/A	Gutter Lip Ht (in)	N/A	N/A	Gutter X Slope (%)	N/A

N/A	Painted X Walk1?	No	N/A	Painted X Walk2?	N/A
			X Walk 1 Direction	To NE		X Walk 2 Direction	N/A
		N/A	X Walk 1 Width (in)	N/A	N/A	X Walk 2 Width (in)	N/A
			X Walk 1 Slope (%)	2.2		X Walk 2 Slope (%)	N/A
			X Walk 1 X Slope (%)	5.4		X Walk 2 X Slope (%)	N/A
		N/A	Ramp inside XWalk1?	N/A	N/A	Ramp inside XWalk2?	N/A
			Road Slope (%)	5.4	N/A	Clear Space?	N/A
			Road X Slope (%)	2.2	N/A	Clear Space to XWalk (in)	N/A
		N/A	Any Obstructions?	N/A	N/A	Storm Grate/Utility Hazard?	N/A
			Obstruction Type			Storm Grate/Utility Type	
				N/A			N/A
					Yes	Surface Condition? (G/P)	Good
Total Cost:		\$ 1850.00
