# Access Compliance Report

## Public Rights-of-Way

### (Curb Ramps)

Intersection ID: 10024872	Main Street: DEWITT_LN	Cross Street: N/A	Location: SE
ADA ID: E3057C4FB1C6	Ramp Type: Perp	Initial Pass/Fail: Fail	Overall Compliance: No
Codes/Mitigation Info/Possible Solution		Field Measurements/Component Compliance	
Severity Score: 10

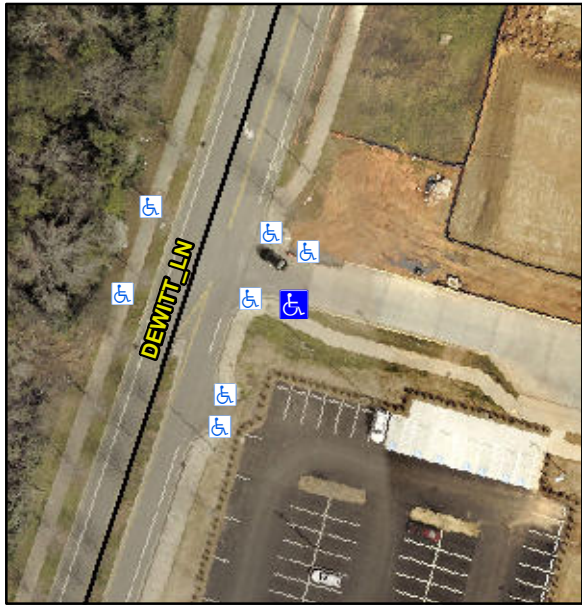
Possible Solutions:						
	Remove & Replace Entire Ramp.						
	Surveyor Notes:						
	N/A						
	PROW/ADA:						
	Not Found, R304.5.1, R304.5.3						
Street 1 Name	ENTRANCE	Compliance	Description	Data	Compliance	Description	Data
Stop Condition-Street 2	StopSign	N/A	Ramp Length (in)	121.0	Yes	Ramp Slope (%)	6.5
Street 2 Name	N/A	No	Ramp Width (in)	47.0	No	Ramp XSlope (%)	2.8
Stop Condition-Street 1	N/A	N/A	Flare Type LT	N/A	N/A	Flare Type RT	N/A
		N/A	Flare Slope LT (%)	N/A	N/A	Flare Slope RT (%)	N/A
		N/A	Flare Traversable LT?	N/A	N/A	Flare Traversable RT?	N/A
		N/A	Landing Length (in)	N/A	N/A	DWS Provided?	N/A
		N/A	Landing Width (in)	N/A	N/A	DWS Contrast?	N/A
		N/A	Landing Slope (%)	N/A	N/A	DWS Length (in)	N/A
		N/A	Landing X Slope (%)	N/A	N/A	DWS Full Width?	N/A
		N/A	Landing Curb? (Y/N)	N/A	N/A	DWS Offset (in)	N/A
		N/A	Shared Landing?	N/A			
		N/A	Gutter Ponding?	N/A	N/A	Gutter Slope (%)	N/A
		N/A	Gutter Lip Ht (in)	N/A	N/A	Gutter X Slope (%)	N/A

N/A	Painted X Walk1?	No	N/A	Painted X Walk2?	N/A
			X Walk 1 Direction	To N		X Walk 2 Direction	N/A
		N/A	X Walk 1 Width (in)	N/A	N/A	X Walk 2 Width (in)	N/A
			X Walk 1 Slope (%)	2.8		X Walk 2 Slope (%)	N/A
			X Walk 1 X Slope (%)	2.8		X Walk 2 X Slope (%)	N/A
		N/A	Ramp inside XWalk1?	N/A	N/A	Ramp inside XWalk2?	N/A
			Road Slope (%)	N/A	N/A	Clear Space?	N/A
			Road X Slope (%)	N/A	N/A	Clear Space to XWalk (in)	N/A
		N/A	Any Obstructions?	N/A	N/A	Storm Grate/Utility Hazard?	N/A
			Obstruction Type			Storm Grate/Utility Type	
					N/A		N/A
					Yes	Surface Condition? (G/P)	Good
