Access Compliance Report

Public Rights-of-Way

(Curb Ramps)

Intersection ID: 15435	Main Street: LATTIMORE_ST	Cross Street: SCOTT_AV	Location: W
ADA ID: E3132485D1C6	Ramp Type: Directional1	Initial Pass/Fail: Fail	Overall Compliance: No
Severity Score: 25			
Codes/Mitigation Info/Possible Solution		Field Measurements/Component Compliance

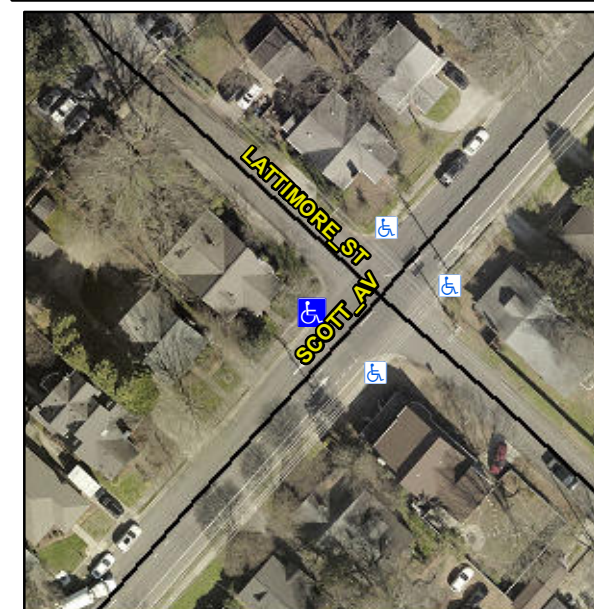
Compliance	Description	Data	Compliance	Description	Data
N/A	Ramp Length (in)	54.0	N/A	Grade Break?	N/A
Yes	Ramp Width (in)	76.0	N/A	Grade Break Slope (%)	0.0
Yes	Ramp Slope (%)	5.6	N/A	Grade Break XSlope (%)	0.0
No	Ramp XSlope (%)	10.2			
N/A	Flare Type LT	N/A	N/A	Flare Type RT	N/A
N/A	Flare Slope LT (%)	N/A	N/A	Flare Slope RT (%)	0.0
N/A	Flare Traversable LT?	N/A	N/A	Flare Traversable RT?	N/A
N/A	Landing Length (in)	0.0	N/A	DWS Provided?	N/A
N/A	Landing Width (in)	0.0	N/A	DWS Contrast?	N/A
N/A	Landing Slope (%)	0.0	N/A	DWS Length (in)	N/A
N/A	Landing X Slope (%)	0.0	N/A	DWS Full Width?	N/A
N/A	Landing Curb? (Y/N)	N/A	N/A	DWS Offset LT (in)	N/A
N/A	Shared Landing?	N/A	N/A	DWS Offset RT (in)	N/A
N/A	Gutter Ponding?	0.0	N/A	Gutter Slope (%)	N/A
N/A	Gutter Lip Ht (in)	0.0	N/A	Gutter X Slope (%)	N/A
N/A	Painted X Walk1?	No		Road Slope (%)	0.9
	X Walk 1 Direction	To NE		Road X Slope (%)	2.8
	X Walk 1 Width (in)	N/A		Clear Space?	N/A

X Walk 1 Slope (%)	0.9	N/A	Clear Space to XWalk (in)	N/A
	X Walk 1 X Slope (%)	2.8	N/A	Storm Grate/Utility Hazard?	N/A
N/A	Ramp inside XWalk1?	N/A		Storm Grate/Utility Type	
N/A	Any Obstructions?	N/A			N/A
	Obstruction Type		Yes	Surface Condition? (G/P)	Good
			N/A	Curb Slope (%)	18.0

Possible Solutions:

Remove & Replace Entire Ramp.

R304.5.3

\$ 1600.00
