Access Compliance Report

Public Rights-of-Way

(Curb Ramps)

Intersection ID: 10570	Main Street: HERRIN_AV	Cross Street: HOLT_ST	Location: NE
ADA ID: E3141FDDBE37	Ramp Type: Perp	Initial Pass/Fail: Fail	Overall Compliance: No
Severity Score: 8.75			
Codes/Mitigation Info/Possible Solution		Field Measurements/Component Compliance

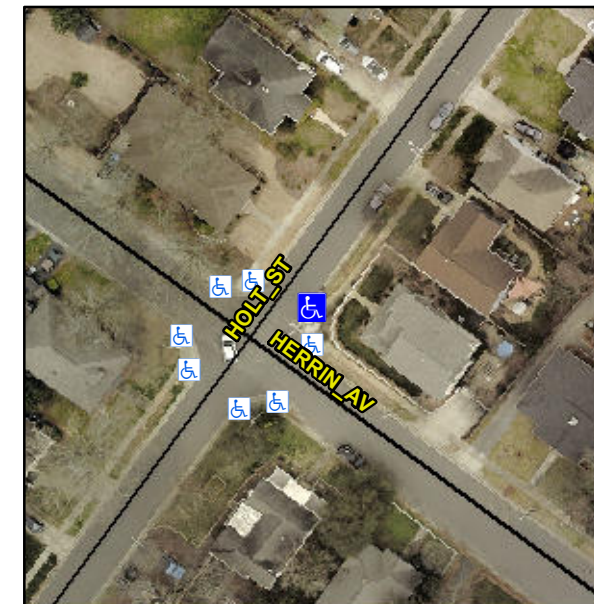
Not Found, R304.5.1

Compliance	Description	Data	Compliance	Description	Data
N/A	Ramp Length (in)	36.5	Yes	Ramp Slope (%)	5.0
No	Ramp Width (in)	46.0	Yes	Ramp XSlope (%)	0.8
N/A	Flare Type LT	N/A	N/A	Flare Type RT	N/A
N/A	Flare Slope LT (%)	N/A	N/A	Flare Slope RT (%)	N/A
N/A	Flare Traversable LT?	N/A	N/A	Flare Traversable RT?	N/A
N/A	Landing Length (in)	N/A	N/A	DWS Provided?	N/A
N/A	Landing Width (in)	N/A	N/A	DWS Contrast?	N/A
N/A	Landing Slope (%)	N/A	N/A	DWS Length (in)	N/A
N/A	Landing X Slope (%)	N/A	N/A	DWS Full Width?	N/A
N/A	Landing Curb? (Y/N)	N/A	N/A	DWS Offset (in)	N/A
N/A	Shared Landing?	N/A			
N/A	Gutter Ponding?	N/A	N/A	Gutter Slope (%)	N/A
N/A	Gutter Lip Ht (in)	N/A	N/A	Gutter X Slope (%)	N/A
N/A	Painted X Walk1?	No	N/A	Painted X Walk2?	N/A
	X Walk 1 Direction	To NW		X Walk 2 Direction	N/A
N/A	X Walk 1 Width (in)	N/A	N/A	X Walk 2 Width (in)	N/A
	X Walk 1 Slope (%)	0.2		X Walk 2 Slope (%)	N/A
	X Walk 1 X Slope (%)	2.5		X Walk 2 X Slope (%)	N/A

N/A	Ramp inside XWalk1?	N/A	N/A	Ramp inside XWalk2?	N/A
	Road Slope (%)	N/A	N/A	Clear Space?	N/A
	Road X Slope (%)	N/A	N/A	Clear Space to XWalk (in)	N/A
N/A	Any Obstructions?	N/A	N/A	Storm Grate/Utility Hazard?	N/A
	Obstruction Type			Storm Grate/Utility Type	
		N/A			N/A
			Yes	Surface Condition? (G/P)	Good

Possible Solutions:

Remove & Replace Entire Ramp.
