## Access Compliance Report Public Rights-of-Way (Curb Ramps)

Intersection ID: 12280	ntersection ID: 12280 Main Street: FIRST_RUN_CT C					Cross Street: HARRISBURG_RD			
								Location:	<u>W</u>
ADA ID: E31F88F1C73A Ramp Type: PerpDiag			Initi	Initial Pass/Fail: Fail Overall Compliance: No				o Severity Score:	33.75
Codes/Mitigation Info/Possible Solution				Field Measurements/Component Compliance

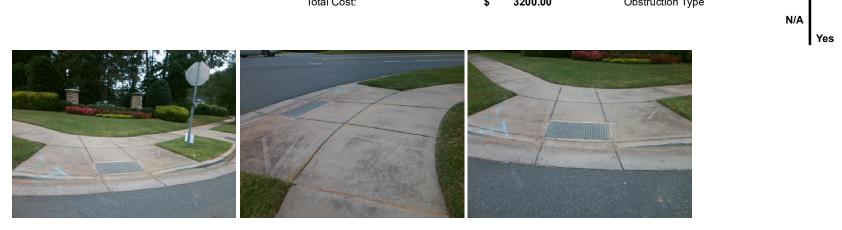
E.		Possible Solutions:		Compliance Description		Data	Data Compliance Description		Data
		Remove & Replace Curb Ra	amp With	N/A	Ramp Length (in)	70.0	No	Ramp Slope (%)	8.4
		Two New Directional Ramp	al Ramps or	No	Ramp Width (in)	44.5	No	Ramp XSlope (%)	5.7
		Equivalent. Surveyor Notes:		N/A	Flare Type LT	N/A	N/A	Flare Type RT	N/A
				N/A	Flare Slope LT (%)	N/A	N/A	Flare Slope RT (%)	N/A
Film to				N/A	Flare Traversable LT?	N/A	N/A	Flare Traversable RT?	N/A
RUNG	e Kult			N/A	Landing Length (in)	N/A	N/A	DWS Provided?	N/A

E. OR				N/A	Landing Width (in)	N/A	N/A	DWS Contrast?	N/A
the second se	Con the	N/A		N/A	Landing Slope (%)	N/A	N/A	DWS Length (in)	N/A
				N/A	Landing X Slope (%)	N/A	N/A	DWS Full Width?	N/A
				N/A	Landing Curb? (Y/N)	N/A	N/A	DWS Offset (in)	N/A
				N/A	Shared Landing?	N/A			
		PROW/ADA:		N/A	Gutter Ponding?	N/A	N/A	Gutter Slope (%)	N/A
		Not Found, R304.5.1, R304.2.2, R304.5.3		N/A	Gutter Lip Ht (in)	N/A	N/A	Gutter X Slope (%)	N/A
				N/A	Painted X Walk1?	No	N/A	Painted X Walk2?	No
		4			X Walk 1 Direction	To SE		X Walk 2 Direction	To NE
				N/A	X Walk 1 Width (in)	N/A	N/A	X Walk 2 Width (in)	N/A
Street 1 Name HARRIS	SBURG RD				X Walk 1 Slope (%)	N/A		X Walk 2 Slope (%)	N/A
Stop Condition-Street 2	None				X Walk 1 X Slope (%)	N/A		X Walk 2 X Slope (%)	N/A
Street 2 Name FIR:	ST RUN CT			N/A	Ramp inside XWalk1?	N/A	N/A	Ramp inside XWalk2?	N/A
Stop Condition-Street 1	StopSign				Road Slope (%)	5.1	N/A	Clear Space?	N/A

Road X Slope (%)	6.2	N/A	Clear Space to XWalk (in)	N/A
				N/A	Any Obstructions?	N/A	N/A	Storm Grate/Utility Hazard?	N/A
		Total Cost:	\$ 3200.00		Obstruction Type			Storm Grate/Utility Type	
						N/A			N/A
