Access Compliance Report

Public Rights-of-Way (Curb Ramps)

Intersection ID: 54301	Main Street: GOLF_LINKS_DR	Cross Street: PROVIDENCE_FARM_LN	Location: SW
ADA ID: E322A9E78809	Ramp Type: Directional1	Initial Pass/Fail: Fail	Overall Compliance: No
		Severity Score: 13.75

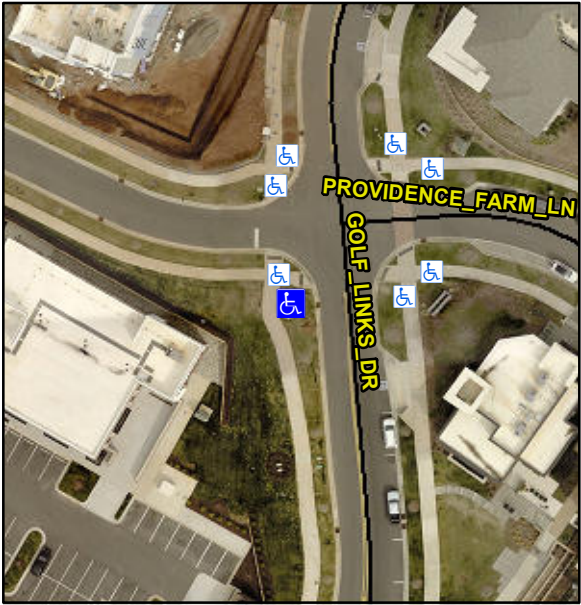
Possible Solutions:				
	Remove & Replace Entire Ramp.				
	Surveyor Notes:				
	N/A				
	PROW/ADA:				
	R304.2.2, R304.5.3				
	Street 1 Name	GOLF LINKS DR			
	Stop Condition-Street 1	StopSign			
	Street 2 Name	N/A			
	Stop Condition-Street 2	N/A			
Total Cost:		\$	1600.00		
		Compliance	Description	Data	Compliance Description Data
		N/A	Ramp Length (in)	64.0	N/A Grade Break? N/A
		Yes	Ramp Width (in)	77.0	N/A Grade Break Slope (%) 0.0
		No	Ramp Slope (%)	11.3	N/A Grade Break XSlope (%) 0.0
		No	Ramp XSlope (%)	2.5	
		N/A	Flare Type LT	N/A	N/A Flare Type RT N/A
		N/A	Flare Slope LT (%)	N/A	N/A Flare Slope RT (%) 0.0
		N/A	Flare Traversable LT?	N/A	N/A Flare Traversable RT? N/A
		N/A	Landing Length (in)	0.0	N/A DWS Provided? N/A
		N/A	Landing Width (in)	0.0	N/A DWS Contrast? N/A
		N/A	Landing Slope (%)	0.0	N/A DWS Length (in) N/A

N/A	Landing X Slope (%)	0.0	N/A DWS Full Width? N/A
		N/A	Landing Curb? (Y/N)	N/A	N/A DWS Offset LT (in) N/A
		N/A	Shared Landing?	N/A	N/A DWS Offset RT (in) N/A
		N/A	Gutter Ponding?	0.0	N/A Gutter Slope (%) N/A
		N/A	Gutter Lip Ht (in)	0.0	N/A Gutter X Slope (%) N/A
		N/A	Painted X Walk1?	No	Road Slope (%) 2.4
			X Walk 1 Direction	To NE	Road X Slope (%) 2.4
			X Walk 1 Width (in)	N/A	Clear Space? N/A
			X Walk 1 Slope (%)	2.4	N/A Clear Space to XWalk (in) N/A
			X Walk 1 X Slope (%)	2.4	N/A Storm Grate/Utility Hazard? N/A
		N/A	Ramp inside XWalk1?	N/A	Storm Grate/Utility Type
		N/A	Any Obstructions?	N/A	N/A
			Obstruction Type		Yes Surface Condition? (G/P) Good
				N/A	N/A Curb Slope (%) 4.1
