Access Compliance Report Public Rights-of-Way (Curb Ramps)

Intersection ID: 15576	Main Street: LAWYERS_RD			Street:	IDLEWILD_RD_NORT	Location:	S		
ADA ID: E35115E7BE3F	Ramp Ty	Ramp Type: PerpDiag			ail: Fail Overall	o Severity Score:	12.5		
Codes/Mitigation Info/Possible Solution				Field Measurements/Component Compliance					
		Possible Solutions:		Compliance Description			Data Compliance Description		
Letter the second secon		Remove & Replace Curb Ramp W	Vith	N/A	Ramp Length (in)	60.0	No	Ramp Slope (%)	9.0
		Two New Directional Ramps or Equivalent.		Yes	Ramp Width (in)	48.0	Yes	Ramp XSlope (%)	1.2
				N/A	Flare Type LT	N/A	N/A	Flare Type RT	N/A
				N/A	Flare Slope LT (%)	N/A	N/A	Flare Slope RT (%)	N/A
Se Calla				N/A	Flare Traversable LT?	N/A	N/A	Flare Traversable RT?	N/A
				N/A	Landing Length (in)	N/A	N/A	DWS Provided?	N/A

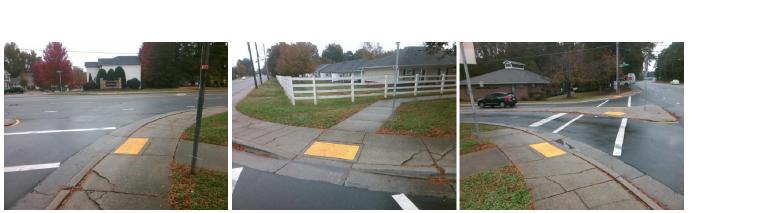
6. 51		Surveyor Notes:		N/A	Landing Width (in)	N/A	N/A	DWS Contrast?	N/A
		N/A		N/A	Landing Slope (%)	N/A	N/A	DWS Length (in)	N/A
				N/A	Landing X Slope (%)	N/A	N/A	DWS Full Width?	N/A
	Mar 15			N/A	Landing Curb? (Y/N)	N/A	N/A	DWS Offset (in)	N/A
		5		N/A	Shared Landing?	N/A			
		PROW/ADA:		N/A	Gutter Ponding?	N/A	N/A	Gutter Slope (%)	N/A
111000000000000000000000000000000000000	11000	R304.2.2		N/A	Gutter Lip Ht (in)	N/A	N/A	Gutter X Slope (%)	N/A
1 4 76 7				N/A	Painted X Walk1?	No	N/A	Painted X Walk2?	Yes
	and the second				X Walk 1 Direction	To NE		X Walk 2 Direction	To NW
and the second	AS			N/A	X Walk 1 Width (in)	N/A	N/A	X Walk 2 Width (in)	82.0
Street 1 Name	LAWYERS RD	-			X Walk 1 Slope (%)	2.9		X Walk 2 Slope (%)	3.3
Stop Condition-Street 2	None				X Walk 1 X Slope (%)	3.1		X Walk 2 X Slope (%)	1.3
Street 2 Name	IDLEWILD RD NORTH			N/A	Ramp inside XWalk1?	N/A	N/A	Ramp inside XWalk2?	Yes
Stop Condition-Street 1	StopSign				Road Slope (%)	0.2	N/A	Clear Space?	N/A

Road X Slope (%)	3.8	N/A	Clear Space to XWalk (in)	N/A
				N/A	Any Obstructions?	N/A	N/A	Storm Grate/Utility Hazard?	N/A
		Total Cost: \$ 32	200.00		Obstruction Type			Storm Grate/Utility Type	
						N/A		/	N/A
