Access Compliance Report

Public Rights-of-Way

(Curb Ramps)

| Intersection ID: 22553 | Main Street: CHESTNUT GROVE LN | Cross Street: MAGNOLIA BRIDGE RD | Location: NW |

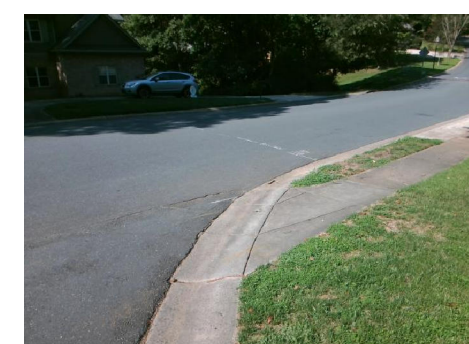
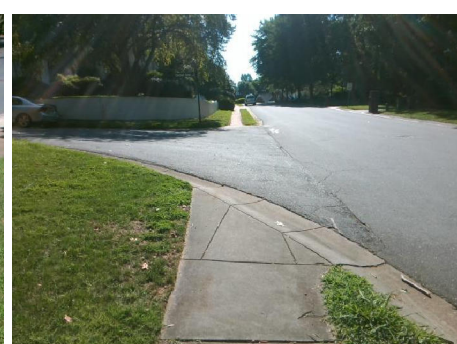
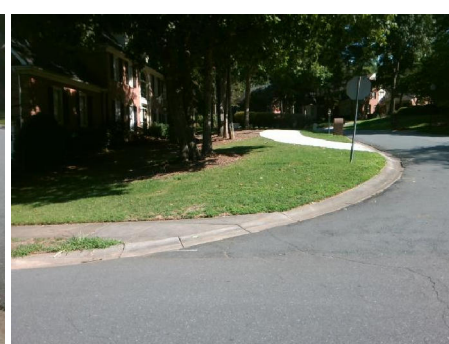
Not Found, R304.5.3

| Compliance | Description | Data | Compliance | Description | Data |
|---|---|---|---|---|---|
| N/A | Ramp Length (in) | 43.0 | Yes | Ramp Slope (%) | 6.0 |
| Yes | Ramp Width (in) | 48.0 | No | Ramp XSlope (%) | 9.9 |

Remove & Replace Curb Ramp With Two New Directional Ramps or Equivalent.

Total Cost: \$ 3200.00
