# Access Compliance Report

## Public Rights-of-Way

### (Curb Ramps)

| Intersection ID: 23717 | Main Street: E WESTINGHOUSE BV | Cross Street: CHINA GROVE CHURCH RD | Location: SE |

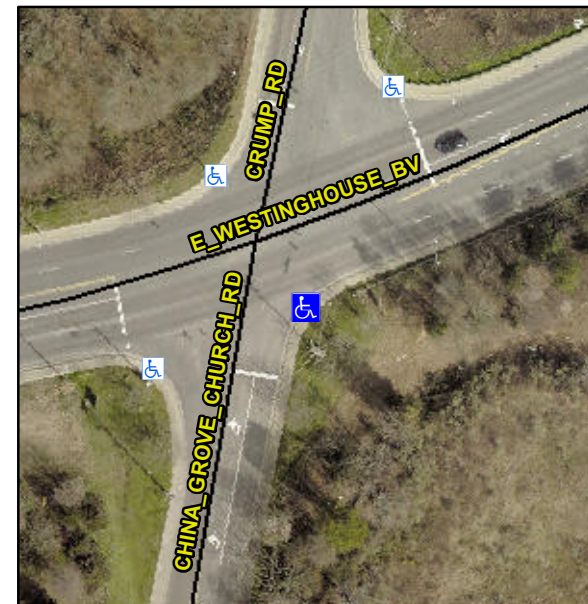
**Not Found, R304.2.2**

| Compliance | Description | Data | Compliance | Description | Data |
|---|---|---|---|---|---|
| N/A | Ramp Length (in) | 60.0 | No | Ramp Slope (%) | 11.4 |

**Remove & Replace Curb Ramp With Two New Directional Ramps or Equivalent.**

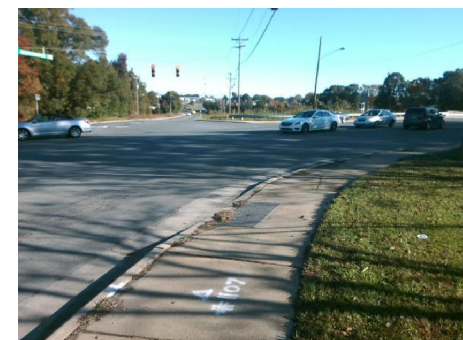
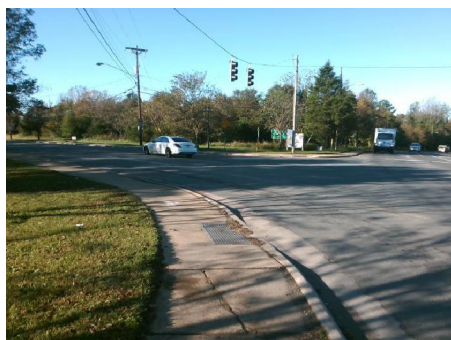
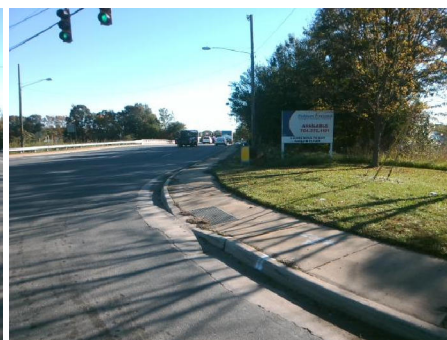
| Compliance | Description | Data | Compliance | Description | Data |
|---|---|---|---|---|---|
| Yes | Ramp Width (in) | 48.0 | Yes | Ramp XSlope (%) | 0.2 |
