Access Compliance Report

Public Rights-of-Way

(Curb Ramps)

Intersection ID: 2835	Main Street: CARDINAL_POINT_RD	Cross Street: RED_CLOVER_LN	Location: S
ADA ID: E3914DBFD7D2	Ramp Type: Perp	Initial Pass/Fail: Fail	Overall Compliance: No
Severity Score: 12.5			
Codes/Mitigation Info/Possible Solution		Field Measurements/Component Compliance

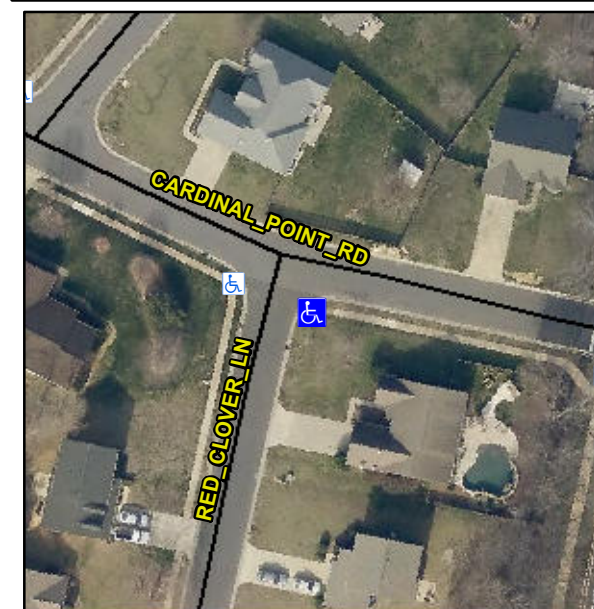
Not Found, R304.2.2

Compliance	Description	Data	Compliance	Description	Data
N/A	Ramp Length (in)	50.5	No	Ramp Slope (%)	9.8
Yes	Ramp Width (in)	48.0	Yes	Ramp XSlope (%)	0.3
N/A	Flare Type LT	N/A	N/A	Flare Type RT	N/A
N/A	Flare Slope LT (%)	N/A	N/A	Flare Slope RT (%)	N/A
N/A	Flare Traversable LT?	N/A	N/A	Flare Traversable RT?	N/A
N/A	Landing Length (in)	N/A	N/A	DWS Provided?	N/A
N/A	Landing Width (in)	N/A	N/A	DWS Contrast?	N/A
N/A	Landing Slope (%)	N/A	N/A	DWS Length (in)	N/A
N/A	Landing X Slope (%)	N/A	N/A	DWS Full Width?	N/A
N/A	Landing Curb? (Y/N)	N/A	N/A	DWS Offset (in)	N/A
N/A	Shared Landing?	N/A			
N/A	Gutter Ponding?	N/A	N/A	Gutter Slope (%)	N/A
N/A	Gutter Lip Ht (in)	N/A	N/A	Gutter X Slope (%)	N/A
N/A	Painted X Walk1?	No	N/A	Painted X Walk2?	N/A
	X Walk 1 Direction	To NW		X Walk 2 Direction	N/A
N/A	X Walk 1 Width (in)	N/A	N/A	X Walk 2 Width (in)	N/A
	X Walk 1 Slope (%)	1.0		X Walk 2 Slope (%)	N/A
	X Walk 1 X Slope (%)	1.2		X Walk 2 X Slope (%)	N/A

N/A	Ramp inside XWalk1?	N/A	N/A	Ramp inside XWalk2?	N/A
	Road Slope (%)	N/A	N/A	Clear Space?	N/A
	Road X Slope (%)	N/A	N/A	Clear Space to XWalk (in)	N/A
N/A	Any Obstructions?	N/A	N/A	Storm Grate/Utility Hazard?	N/A
	Obstruction Type			Storm Grate/Utility Type	
		N/A			N/A
			Yes	Surface Condition? (G/P)	Good

Possible Solutions:

Remove & Replace Entire Ramp.

Total Cost: \$ 1850.00
