Access Compliance Report

Public Rights-of-Way

(Curb Ramps)

Intersection ID: 10477	Main Street: HAMILTON_ST	Cross Street: POLK_ST	Location: SE
ADA ID: E3925918E7FC	Ramp Type: Perp	Initial Pass/Fail: Fail	Overall Compliance: No
Severity Score: 16.25			
Codes/Mitigation Info/Possible Solution		Field Measurements/Component Compliance

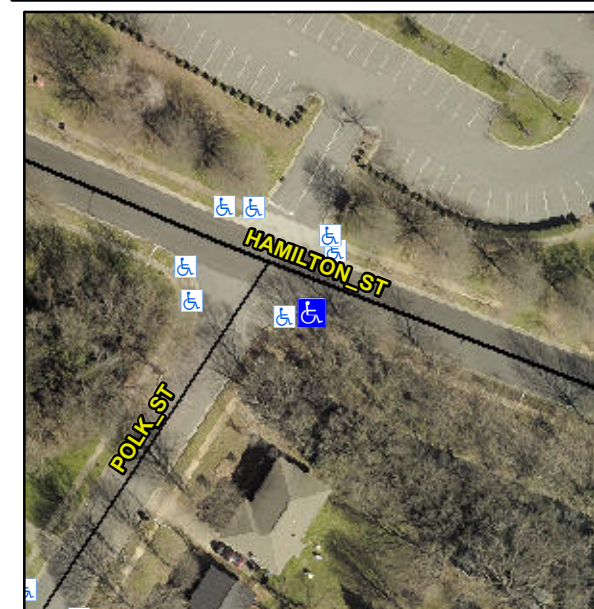
PROW/ADA:

Not Found, R304.5.3, R302.7

Compliance	Description	Data	Compliance	Description	Data
N/A	Ramp Length (in)	68.5	Yes	Ramp Slope (%)	5.2
Yes	Ramp Width (in)	56.0	No	Ramp XSlope (%)	2.2
N/A	Flare Type LT	N/A	N/A	Flare Type RT	N/A
N/A	Flare Slope LT (%)	N/A	N/A	Flare Slope RT (%)	N/A
N/A	Flare Traversable LT?	N/A	N/A	Flare Traversable RT?	N/A
N/A	Landing Length (in)	N/A	N/A	DWS Provided?	N/A
N/A	Landing Width (in)	N/A	N/A	DWS Contrast?	N/A
N/A	Landing Slope (%)	N/A	N/A	DWS Length (in)	N/A
N/A	Landing X Slope (%)	N/A	N/A	DWS Full Width?	N/A
N/A	Landing Curb? (Y/N)	N/A	N/A	DWS Offset (in)	N/A
N/A	Shared Landing?	N/A			
N/A	Gutter Ponding?	N/A	N/A	Gutter Slope (%)	N/A
N/A	Gutter Lip Ht (in)	N/A	N/A	Gutter X Slope (%)	N/A
N/A	Painted X Walk1?	No	N/A	Painted X Walk2?	N/A
	X Walk 1 Direction	To NE		X Walk 2 Direction	N/A
N/A	X Walk 1 Width (in)	N/A	N/A	X Walk 2 Width (in)	N/A
	X Walk 1 Slope (%)	4.2		X Walk 2 Slope (%)	N/A
	X Walk 1 X Slope (%)	1.7		X Walk 2 X Slope (%)	N/A

N/A	Ramp inside XWalk1?	N/A	N/A	Ramp inside XWalk2?	N/A
	Road Slope (%)	N/A	N/A	Clear Space?	N/A
	Road X Slope (%)	N/A	N/A	Clear Space to XWalk (in)	N/A
N/A	Any Obstructions?	N/A	N/A	Storm Grate/Utility Hazard?	N/A
	Obstruction Type			Storm Grate/Utility Type	
		N/A			N/A
		No		Surface Condition? (G/P)	Poor

Possible Solutions:

Remove & Replace Entire Ramp.

Total Cost: \$ 1850.00
