## Access Compliance Report Public Rights-of-Way (Curb Ramps)

,					
Intersection ID: 46819	Main Str	reet: CLAUDE_FREEMAN_DR	Cross	Street:	AZALEA_HILLS_DR	Location:	SW		
ADA ID: E3A51B619B15	Ramp Type: Perp			Initial Pass/Fail: Pass Overall Compliance: No				o Severity Score:	10
Codes/Mitigation Info/Possible Solution				Field Measurements/Component Compliance					
		Possible Solutions:		Compliance Description			Data Compliance Description		
		Remove & Replace Entire Ram	<b>D</b> .	N/A	Ramp Length (in)	49.0	Yes	Ramp Slope (%)	7.3

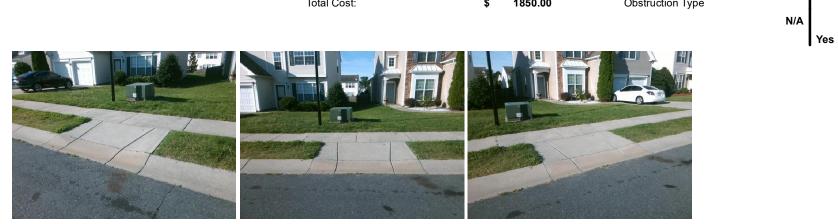
1.	Yes	Ramp Width (in)	49.0	Yes	Ramp XSlope (%)	0.7
	Carling and annual			N/A	Flare Type LT	Sloped	N/A	Flare Type RT	N/A
	1 10-1			N/A	Flare Slope LT (%)	6.3	Yes	Flare Slope RT (%)	9.0
				N/A	Flare Traversable LT?	Yes	N/A	Flare Traversable RT?	Yes
Marganetter 2	E Concess			Yes	Landing Length (in)	49.0	No	DWS Provided?	No
AVALIER HILLS DR &		Surveyor Notes:		Yes	Landing Width (in)	63.5	N/A	DWS Contrast?	No
interes in the	<u>6</u>	N/A		Yes	Landing Slope (%)	0.7	N/A	DWS Length (in)	N/A
TA TO AND A		11/2		Yes	Landing X Slope (%)	0.7	N/A	DWS Full Width?	No
A TO DE LEVINE				N/A	Landing Curb? (Y/N)	No		DWS Offset (in)	N/A
				N/A	Shared Landing?	No		()	
		PROW/ADA:		Yes	Gutter Ponding?	No	Yes	Gutter Slope (%)	1.7
the state of the s	Pot .	Not Found, R305		Yes	Gutter Lip Ht (in)	0.0	Yes	Gutter X Slope (%)	1.3
the start of	Not Found, K305		N/A	Painted X Walk1?	No	N/A	Painted X Walk2?	N/A	
Street 1 Name AZALEA HILLS DR				10/4	X Walk 1 Direction	To N	11/2	X Walk 2 Direction	N/A

N/A	X Walk 1 Width (in)	N/A	N/A	X Walk 2 Width (in)	N/A
				N/A		2.7	IN/A		N/A
					X Walk 1 Slope (%)	1.2		X Walk 2 Slope (%)	N/A N/A
Stop Condition-Street 2	None N/A			N// A	X Walk 1 X Slope (%)			X Walk 2 X Slope (%)	
Street 2 Name				N/A	Ramp inside XWalk1?	N/A	N/A	Ramp inside XWalk2?	N/A
Stop Condition-Street 1	N/A				Road Slope (%)	N/A	N/A	Clear Space?	Yes
					Road X Slope (%)	N/A	N/A	Clear Space to XWalk (in)	N/A
				Yes	Any Obstructions?	No	Yes	Storm Grate/Utility Hazard?	No
		Total Cost: \$	1850.00		Obstruction Type			Storm Grate/Utility Type	
						N/A			N/A
