Access Compliance Report

Public Rights-of-Way

(Curb Ramps)

Intersection ID: 44825	Main Street: SPRING_OAK_DR	Cross Street: HIRAM_ST	Location: NW
ADA ID: E3B2B6E5BAD4	Ramp Type: Perp	Initial Pass/Fail: Fail	Overall Compliance: No
			Severity Score: 21.25

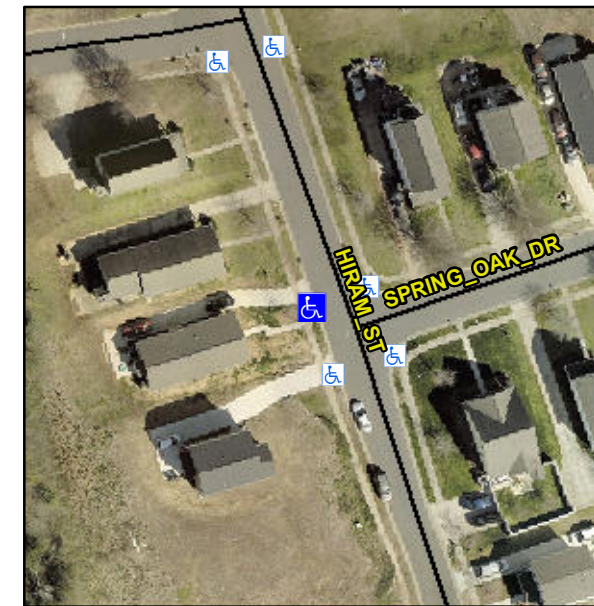
Not Found, R304.5.1, R304.5.3

Compliance	Description	Data	Compliance	Description	Data
N/A	Ramp Length (in)	49.0	Yes	Ramp Slope (%)	6.9
No	Ramp Width (in)	47.0	No	Ramp XSlope (%)	5.2
N/A	Flare Type LT	N/A	N/A	Flare Type RT	N/A
N/A	Flare Slope LT (%)	N/A	N/A	Flare Slope RT (%)	N/A
N/A	Flare Traversable LT?	N/A	N/A	Flare Traversable RT?	N/A
N/A	Landing Length (in)	N/A	N/A	DWS Provided?	N/A
N/A	Landing Width (in)	N/A	N/A	DWS Contrast?	N/A
N/A	Landing Slope (%)	N/A	N/A	DWS Length (in)	N/A
N/A	Landing X Slope (%)	N/A	N/A	DWS Full Width?	N/A
N/A	Landing Curb? (Y/N)	N/A	N/A	DWS Offset (in)	N/A
N/A	Shared Landing?	N/A			
N/A	Gutter Ponding?	N/A	N/A	Gutter Slope (%)	N/A
N/A	Gutter Lip Ht (in)	N/A	N/A	Gutter X Slope (%)	N/A
N/A	Painted X Walk1?	No	N/A	Painted X Walk2?	N/A
	X Walk 1 Direction	To E		X Walk 2 Direction	N/A
N/A	X Walk 1 Width (in)	N/A	N/A	X Walk 2 Width (in)	N/A
	X Walk 1 Slope (%)	1.7		X Walk 2 Slope (%)	N/A
	X Walk 1 X Slope (%)	4.6		X Walk 2 X Slope (%)	N/A

Remove & Replace Entire Ramp.
