Access Compliance Report

Public Rights-of-Way

(Curb Ramps)

Intersection ID: 52718	Main Street: AGAVA_LN	Cross Street: MAIDENHAIR_CT	Location: NE
ADA ID: E3B88BDC0C6C	Ramp Type: Perp	Initial Pass/Fail: Fail	Overall Compliance: No
Severity Score: 1.25			
Codes/Mitigation Info/Possible Solution		Field Measurements/Component Compliance

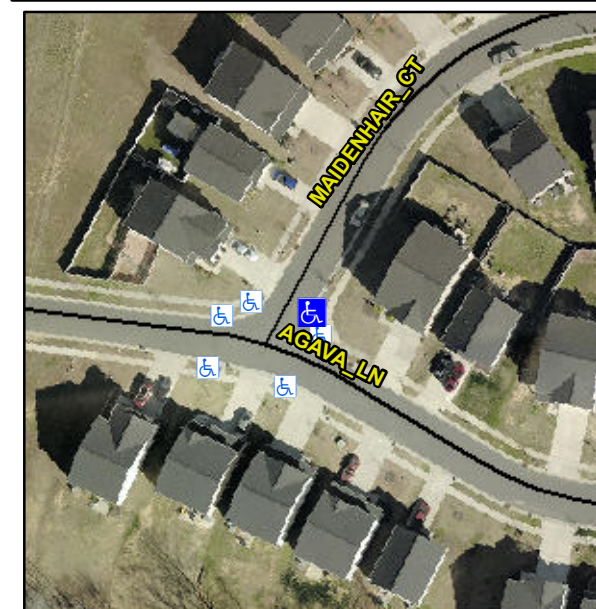
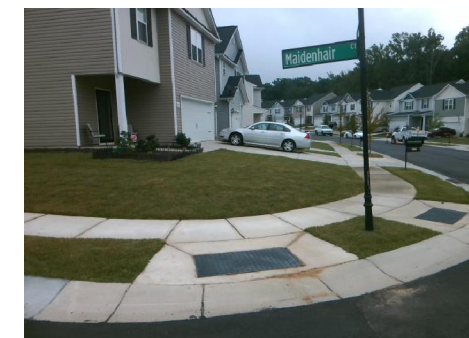
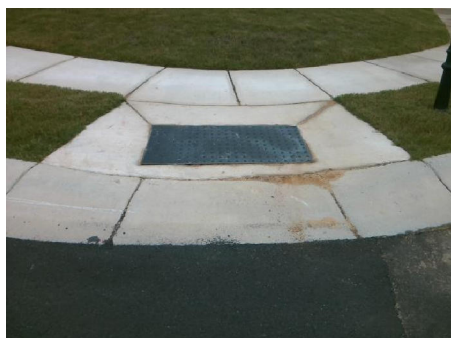
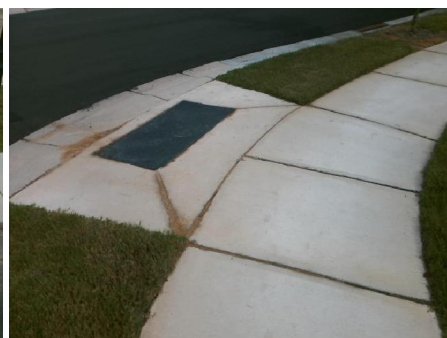
Not Found, R304.5.3

Compliance	Description	Data	Compliance	Description	Data
N/A	Ramp Length (in)	49.0	Yes	Ramp Slope (%)	5.2
Yes	Ramp Width (in)	48.0	No	Ramp XSlope (%)	2.5
N/A	Flare Type LT	N/A	N/A	Flare Type RT	N/A
N/A	Flare Slope LT (%)	N/A	N/A	Flare Slope RT (%)	N/A
N/A	Flare Traversable LT?	N/A	N/A	Flare Traversable RT?	N/A
N/A	Landing Length (in)	N/A	N/A	DWS Provided?	N/A
N/A	Landing Width (in)	N/A	N/A	DWS Contrast?	N/A
N/A	Landing Slope (%)	N/A	N/A	DWS Length (in)	N/A
N/A	Landing X Slope (%)	N/A	N/A	DWS Full Width?	N/A
N/A	Landing Curb? (Y/N)	N/A	N/A	DWS Offset (in)	N/A
N/A	Shared Landing?	N/A			
N/A	Gutter Ponding?	N/A	N/A	Gutter Slope (%)	N/A
N/A	Gutter Lip Ht (in)	N/A	N/A	Gutter X Slope (%)	N/A
N/A	Painted X Walk1?	No	N/A	Painted X Walk2?	N/A
	X Walk 1 Direction	To W		X Walk 2 Direction	N/A
N/A	X Walk 1 Width (in)	N/A	N/A	X Walk 2 Width (in)	N/A
	X Walk 1 Slope (%)	2.2		X Walk 2 Slope (%)	N/A
	X Walk 1 X Slope (%)	1.3		X Walk 2 X Slope (%)	N/A

N/A	Ramp inside XWalk1?	N/A	N/A	Ramp inside XWalk2?	N/A
	Road Slope (%)	N/A	N/A	Clear Space?	N/A
	Road X Slope (%)	N/A	N/A	Clear Space to XWalk (in)	N/A
N/A	Any Obstructions?	N/A	N/A	Storm Grate/Utility Hazard?	N/A
	Obstruction Type			Storm Grate/Utility Type	
		N/A			N/A
			Yes	Surface Condition? (G/P)	Good

Possible Solutions:

Remove & Replace Entire Ramp.

Total Cost: \$ 1850.00
