# Access Compliance Report

## Public Rights-of-Way

### (Curb Ramps)

Intersection ID: N/A	Main Street: GROVER RD	Cross Street: N/A	Location: E
ADA ID: E3C38BC32259	Ramp Type: Perp	Initial Pass/Fail: Fail	Overall Compliance: No
Codes/Mitigation Info/Possible Solution		Field Measurements/Component Compliance

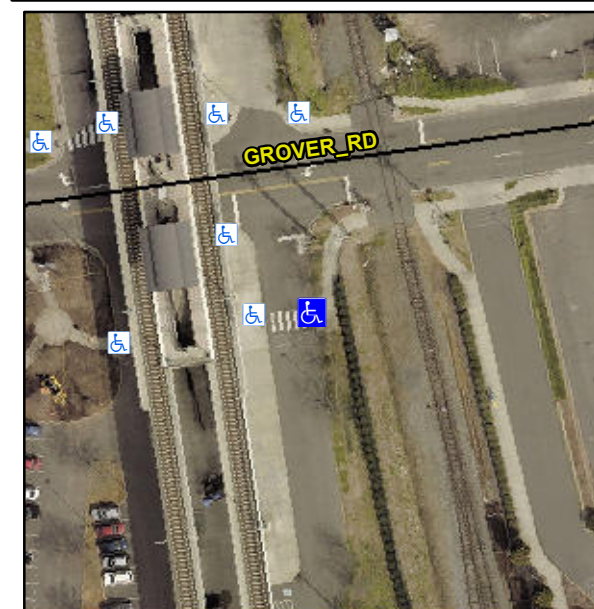
**R304.5.1, R304.5.3**

Compliance	Description	Data	Compliance	Description	Data
N/A	Ramp Length (in)	72.0	Yes	Ramp Slope (%)	7.9
No	Ramp Width (in)	47.0	No	Ramp XSlope (%)	6.1
N/A	Flare Type LT	N/A	N/A	Flare Type RT	N/A
N/A	Flare Slope LT (%)	N/A	N/A	Flare Slope RT (%)	N/A
N/A	Flare Traversable LT?	No	N/A	Flare Traversable RT?	No
N/A	Landing Length (in)	N/A	N/A	DWS Provided?	N/A
N/A	Landing Width (in)	N/A	N/A	DWS Contrast?	N/A
N/A	Landing Slope (%)	N/A	N/A	DWS Length (in)	N/A
N/A	Landing X Slope (%)	N/A	N/A	DWS Full Width?	N/A
N/A	Landing Curb? (Y/N)	N/A	N/A	DWS Offset (in)	N/A
N/A	Shared Landing?	N/A			
N/A	Gutter Ponding?	N/A	N/A	Gutter Slope (%)	N/A
N/A	Gutter Lip Ht (in)	N/A	N/A	Gutter X Slope (%)	N/A
N/A	Painted X Walk1?	Yes	N/A	Painted X Walk2?	N/A
	X Walk 1 Direction	To W		X Walk 2 Direction	N/A
N/A	X Walk 1 Width (in)	121.0	N/A	X Walk 2 Width (in)	N/A
	X Walk 1 Slope (%)	1.1		X Walk 2 Slope (%)	N/A
	X Walk 1 X Slope (%)	1.3		X Walk 2 X Slope (%)	N/A

**Remove & Replace Entire Ramp.**
