## Access Compliance Report Public Rights-of-Way (Curb Ramps)

Intersection ID: 48134 Main Street: SQUIRREL\_TRAIL\_LN Cross Street: ACORN\_CREEK\_LN Location: SW

ADA ID: E3CE5AFC96EE Ramp Type: PerpDiag Initial Pass/Fail: Fail Overall Compliance: No Severity Score: 8.75

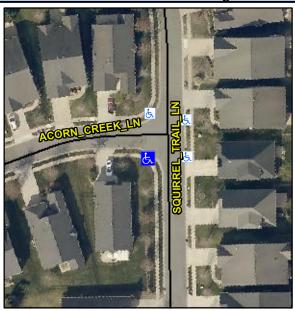
Not Found, R304.5.1

| Field Measurements/Component Compliance | | | | | |
|---|---|---|---|---|---|
| No | Ramp Width (in) | 38.0 | Yes | Ramp XSlope (%) | 1.7 |

Remove & Replace Curb Ramp With
Two New Directional Ramps or
Equivalent.
