Access Compliance Report

Public Rights-of-Way

(Curb Ramps)

Intersection ID: 51478	Main Street: BENDERLOCH_DR	Cross Street: MEADOW_BOTTOM_RD	Location: S
ADA ID: E3D84BD62E0B	Ramp Type: PerpDiag	Initial Pass/Fail: Fail	Overall Compliance: No
Severity Score: 12.5			
Codes/Mitigation Info/Possible Solution		Field Measurements/Component Compliance

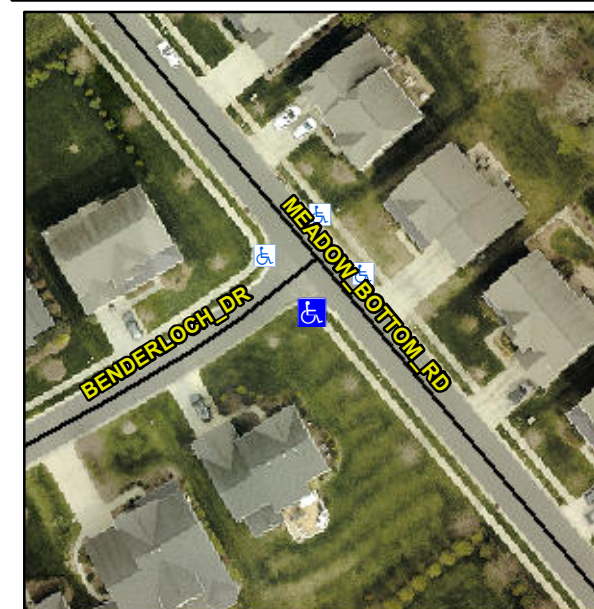
Not Found, R304.5.3

Compliance	Description	Data	Compliance	Description	Data
N/A	Ramp Length (in)	49.0	Yes	Ramp Slope (%)	6.0
Yes	Ramp Width (in)	48.0	No	Ramp XSlope (%)	5.4
N/A	Flare Type LT	N/A	N/A	Flare Type RT	N/A
N/A	Flare Slope LT (%)	N/A	N/A	Flare Slope RT (%)	N/A
N/A	Flare Traversable LT?	N/A	N/A	Flare Traversable RT?	N/A
N/A	Landing Length (in)	N/A	N/A	DWS Provided?	N/A
N/A	Landing Width (in)	N/A	N/A	DWS Contrast?	N/A
N/A	Landing Slope (%)	N/A	N/A	DWS Length (in)	N/A
N/A	Landing X Slope (%)	N/A	N/A	DWS Full Width?	N/A
N/A	Landing Curb? (Y/N)	N/A	N/A	DWS Offset (in)	N/A
N/A	Shared Landing?	N/A			
N/A	Gutter Ponding?	N/A	N/A	Gutter Slope (%)	N/A
N/A	Gutter Lip Ht (in)	N/A	N/A	Gutter X Slope (%)	N/A
N/A	Painted X Walk1?	No	N/A	Painted X Walk2?	No
	X Walk 1 Direction	To NW		X Walk 2 Direction	To E
N/A	X Walk 1 Width (in)	N/A	N/A	X Walk 2 Width (in)	N/A
	X Walk 1 Slope (%)	0.2		X Walk 2 Slope (%)	N/A
	X Walk 1 X Slope (%)	1.2		X Walk 2 X Slope (%)	N/A

N/A	Ramp inside XWalk1?	N/A	N/A	Ramp inside XWalk2?	N/A
	Road Slope (%)	1.2	N/A	Clear Space?	N/A
	Road X Slope (%)	0.2	N/A	Clear Space to XWalk (in)	N/A
N/A	Any Obstructions?	N/A	N/A	Storm Grate/Utility Hazard?	N/A
	Obstruction Type			Storm Grate/Utility Type	
		N/A			N/A
		Yes		Surface Condition? (G/P)	Good

Remove & Replace Curb Ramp With Two New Directional Ramps or Equivalent.
