Access Compliance Report

Public Rights-of-Way

(Curb Ramps)

Intersection ID: 50119	Main Street: PARK_SOUTH_STATION_BV	Cross Street: PARK ROYAL_AV	Location: NE
ADA ID: E3E01E805CFB	Ramp Type: Perp	Initial Pass/Fail: Fail	Overall Compliance: No
Severity Score: 22.5			
Codes/Mitigation Info/Possible Solution		Field Measurements/Component Compliance

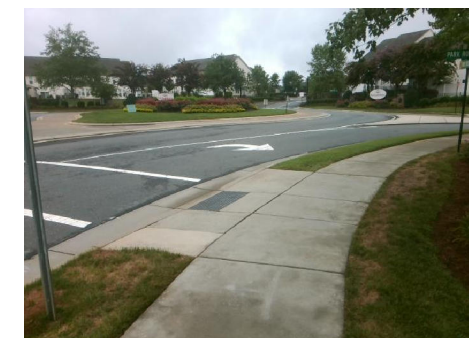
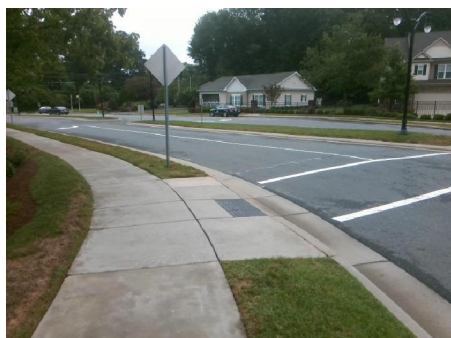
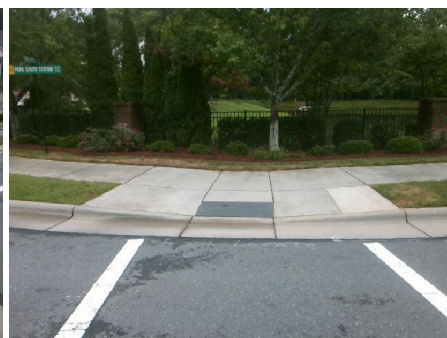
Compliance	Description	Data	Compliance	Description	Data
N/A	Ramp Length (in)	46.0	No	Ramp Slope (%)	8.8
No	Ramp Width (in)	45.5	No	Ramp XSlope (%)	3.3
N/A	Flare Type LT	N/A	N/A	Flare Type RT	N/A
N/A	Flare Slope LT (%)	N/A	N/A	Flare Slope RT (%)	N/A
N/A	Flare Traversable LT?	N/A	N/A	Flare Traversable RT?	N/A
N/A	Landing Length (in)	N/A	N/A	DWS Provided?	N/A
N/A	Landing Width (in)	N/A	N/A	DWS Contrast?	N/A
N/A	Landing Slope (%)	N/A	N/A	DWS Length (in)	N/A
N/A	Landing X Slope (%)	N/A	N/A	DWS Full Width?	N/A
N/A	Landing Curb? (Y/N)	N/A	N/A	DWS Offset (in)	N/A
N/A	Shared Landing?	N/A			
N/A	Gutter Ponding?	N/A	N/A	Gutter Slope (%)	N/A
N/A	Gutter Lip Ht (in)	N/A	N/A	Gutter X Slope (%)	N/A
N/A	Painted X Walk1?	Yes	N/A	Painted X Walk2?	N/A
	X Walk 1 Direction	To SE		X Walk 2 Direction	N/A
N/A	X Walk 1 Width (in)	110.0	N/A	X Walk 2 Width (in)	N/A
	X Walk 1 Slope (%)	6.6		X Walk 2 Slope (%)	N/A
	X Walk 1 X Slope (%)	2.1		X Walk 2 X Slope (%)	N/A

N/A	Ramp inside XWalk1?	Yes	N/A	Ramp inside XWalk2?	N/A
	Road Slope (%)	N/A	N/A	Clear Space?	N/A
	Road X Slope (%)	N/A	N/A	Clear Space to XWalk (in)	N/A
N/A	Any Obstructions?	N/A	N/A	Storm Grate/Utility Hazard?	N/A
	Obstruction Type			Storm Grate/Utility Type	
		N/A			N/A
		Yes		Surface Condition? (G/P)	Good

Remove & Replace Entire Ramp.
