Access Compliance Report

Public Rights-of-Way

(Curb Ramps)

Intersection ID: 47272	Main Street: LEAHURST_CT	Cross Street: LIDDINGTON_RD	Location: SE
ADA ID: E4024F6212F0	Ramp Type: PerpDiag	Initial Pass/Fail: Fail	Overall Compliance: No
Severity Score: 8.75			
Codes/Mitigation Info/Possible Solution		Field Measurements/Component Compliance

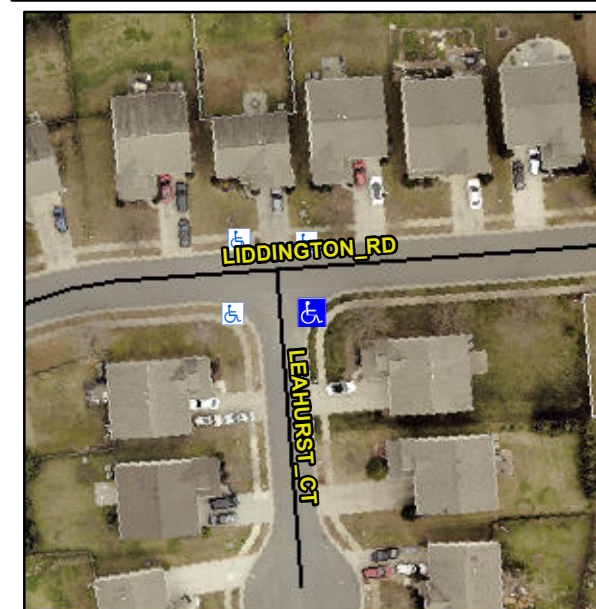
Not Found, R304.5.1

Compliance	Description	Data	Compliance	Description	Data
N/A	Ramp Length (in)	49.0	Yes	Ramp Slope (%)	6.3
No	Ramp Width (in)	43.0	Yes	Ramp XSlope (%)	1.5
N/A	Flare Type LT	N/A	N/A	Flare Type RT	N/A
N/A	Flare Slope LT (%)	N/A	N/A	Flare Slope RT (%)	N/A
N/A	Flare Traversable LT?	N/A	N/A	Flare Traversable RT?	N/A
N/A	Landing Length (in)	N/A	N/A	DWS Provided?	N/A
N/A	Landing Width (in)	N/A	N/A	DWS Contrast?	N/A
N/A	Landing Slope (%)	N/A	N/A	DWS Length (in)	N/A
N/A	Landing X Slope (%)	N/A	N/A	DWS Full Width?	N/A
N/A	Landing Curb? (Y/N)	N/A	N/A	DWS Offset (in)	N/A
N/A	Shared Landing?	N/A			
N/A	Gutter Ponding?	N/A	N/A	Gutter Slope (%)	N/A
N/A	Gutter Lip Ht (in)	N/A	N/A	Gutter X Slope (%)	N/A
N/A	Painted X Walk1?	No	N/A	Painted X Walk2?	No
	X Walk 1 Direction	To N		X Walk 2 Direction	To W
N/A	X Walk 1 Width (in)	N/A	N/A	X Walk 2 Width (in)	N/A
	X Walk 1 Slope (%)	2.3		X Walk 2 Slope (%)	1.5
	X Walk 1 X Slope (%)	1.2		X Walk 2 X Slope (%)	1.6

N/A	Ramp inside XWalk1?	N/A	N/A	Ramp inside XWalk2?	N/A
	Road Slope (%)	1.8	N/A	Clear Space?	N/A
	Road X Slope (%)	0.3	N/A	Clear Space to XWalk (in)	N/A
N/A	Any Obstructions?	N/A	N/A	Storm Grate/Utility Hazard?	N/A
	Obstruction Type			Storm Grate/Utility Type	
		N/A			N/A
			Yes	Surface Condition? (G/P)	Good

Remove & Replace Curb Ramp With Two New Directional Ramps or Equivalent.

Total Cost: \$ 3200.00
