Access Compliance Report

Public Rights-of-Way

(Curb Ramps)

Intersection ID: 14762	Main Street: E_TREMONT_AV	Cross Street: SPRINGDALE_AV	Location: S
ADA ID: E406BA395FFE	Ramp Type: BlendTrans1	Initial Pass/Fail: Fail	Overall Compliance: No
Severity Score: 1.25			
Codes/Mitigation Info/Possible Solution		Field Measurements/Component Compliance

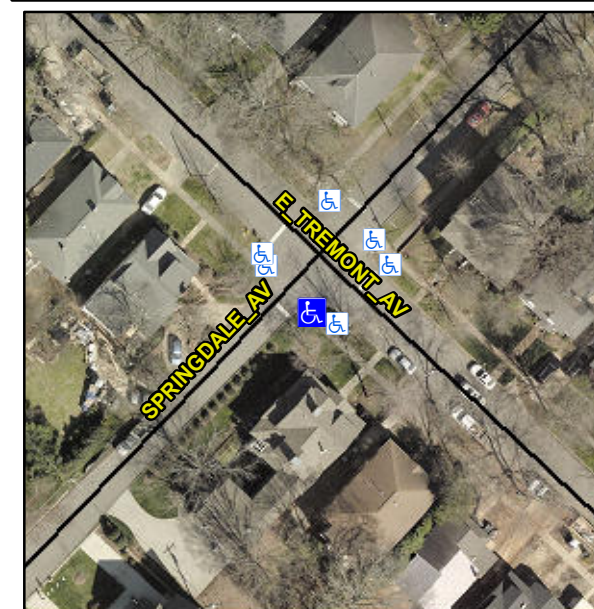
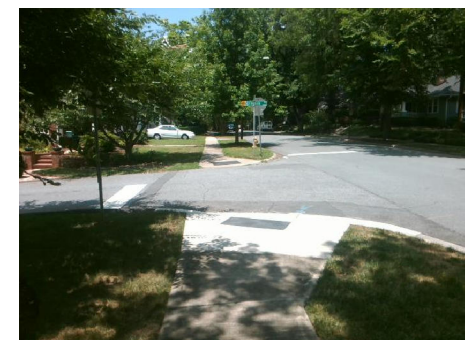
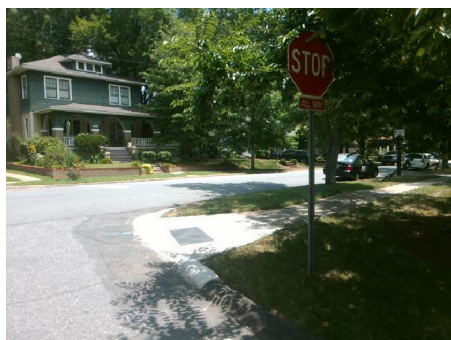
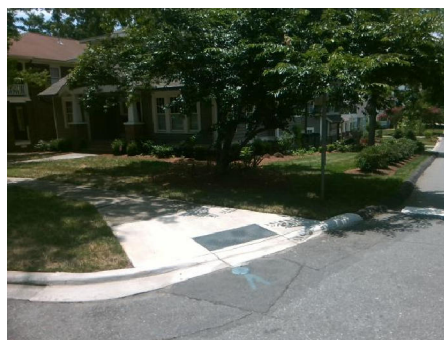
Surveyor Notes:

DWS WARPED

PROW/ADA:

R304.5.3

Compliance	Description	Data	Compliance	Description	Data
N/A	Ramp Length (in)	76.5	Yes	BlendTrans Slope (%)	2.8
Yes	Ramp Width (in)	48.0	No	BlendTrans XSlope (%)	2.9
N/A	Flare Type LT	N/A	N/A	Flare Type RT	N/A
N/A	Flare Slope LT (%)	N/A	N/A	Flare Slope RT (%)	N/A
N/A	Flare Traversable LT?	N/A	N/A	Flare Traversable RT?	N/A
N/A	Landing Length (in)	N/A	N/A	DWS Provided?	N/A
N/A	Landing Width (in)	N/A	N/A	DWS Contrast?	N/A
N/A	Landing Slope (%)	N/A	N/A	DWS Length (in)	N/A
N/A	Landing X Slope (%)	N/A	N/A	DWS Full Width?	N/A
N/A	Landing Curb? (Y/N)	N/A	N/A	DWS Offset (in)	N/A
N/A	Shared Landing?	N/A			
N/A	Gutter Ponding?	N/A	N/A	Gutter Slope (%)	N/A
N/A	Gutter Lip Ht (in)	1.0	N/A	Gutter X Slope (%)	N/A
N/A	Painted X Walk1?	No	N/A	Painted X Walk2?	N/A
	X Walk 1 Direction	To NW		X Walk 2 Direction	N/A
	X Walk 1 Width (in)	N/A		X Walk 2 Width (in)	N/A
	X Walk 1 Slope (%)	3.8		X Walk 2 Slope (%)	N/A
	X Walk 1 X Slope (%)	4.2		X Walk 2 X Slope (%)	N/A

Possible Solutions:

Remove & Replace Curb Ramp With Two New Directional Ramps or Equivalent.
