Access Compliance Report

Public Rights-of-Way

(Curb Ramps)

| Intersection ID: 31403 | Main Street: BITTERROOT_CT | Cross Street: BRAWER_FARM_DR | Location: S |

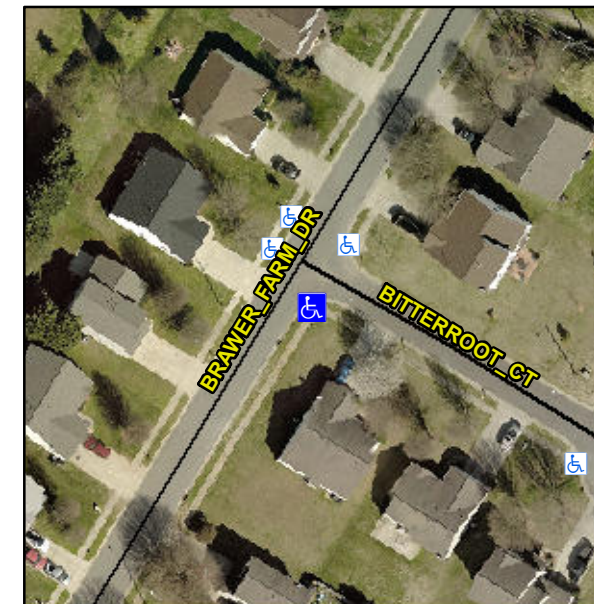
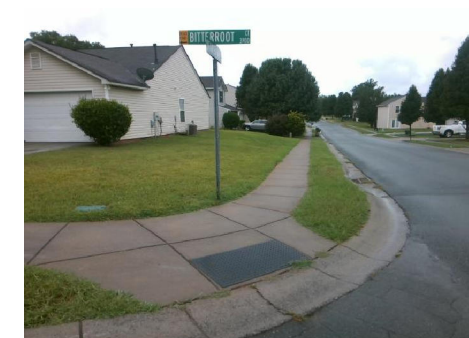
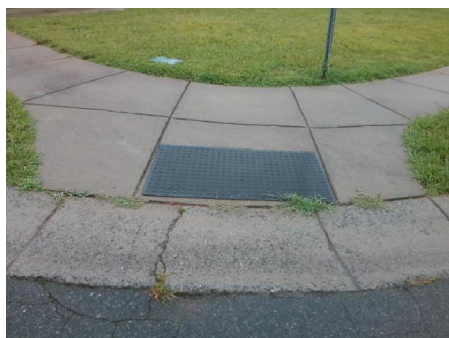
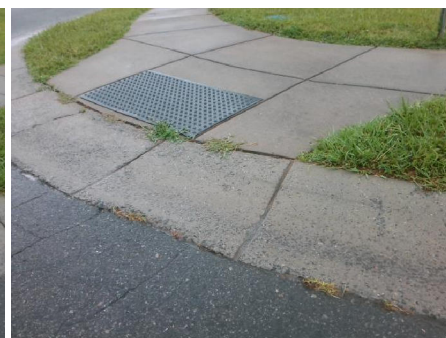
| ADA ID: E40A4DF14C1C | Ramp Type: PerpDiag | Initial Pass/Fail: Fail | Overall Compliance: No |
| Severity Score: 25 | | | |

R304.2.2, R304.5.3

| Compliance | Description | Data | Compliance | Description | Data |
|---|---|---|---|---|---|
| N/A | Ramp Length (in) | 45.0 | No | Ramp Slope (%) | 8.8 |
| Yes | Ramp Width (in) | 49.0 | No | Ramp XSlope (%) | 5.3 |

Remove & Replace Curb Ramp With Two New Directional Ramps or Equivalent.

Total Cost: \$ 3200.00
