Access Compliance Report

Public Rights-of-Way

(Curb Ramps)

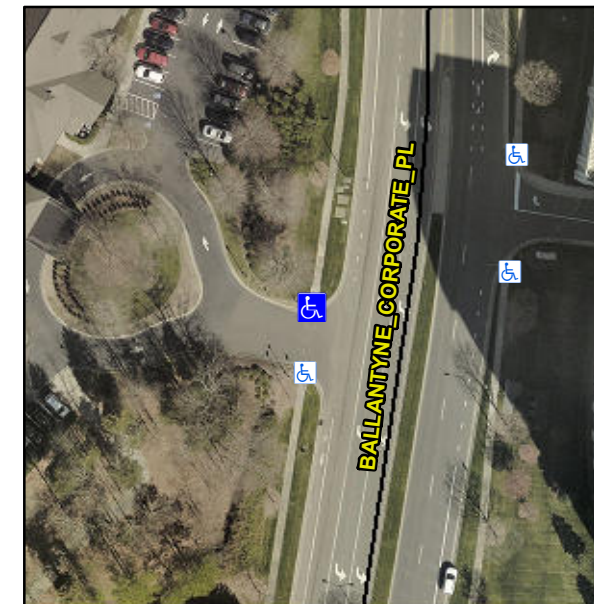
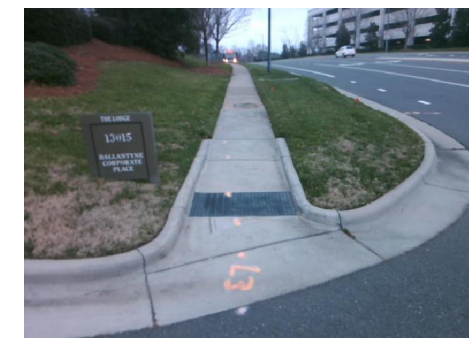
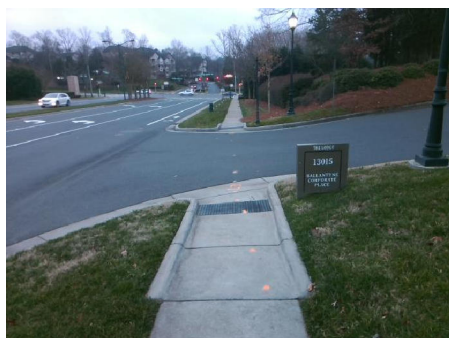
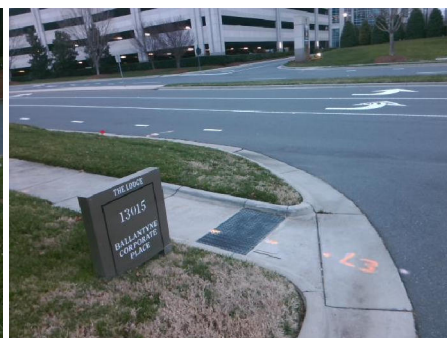
Intersection ID: 10020374	Main Street: BALLANTYNE CORPORATE PL	Cross Street: N/A	Location: NW
ADA ID: E420FFEE5478	Ramp Type: Directional	Initial Pass/Fail: Fail	Overall Compliance: No
Severity Score: 22.5			
Codes/Mitigation Info/Possible Solution		Field Measurements/Component Compliance

R304.5.1, R304.2.2, R304.5.3

Compliance	Description	Data	Compliance	Description	Data
N/A	Ramp Length (in)	139.0	N/A	Grade Break?	N/A
No	Ramp Width (in)	45.0	N/A	Grade Break Slope (%)	0.0
No	Ramp Slope (%)	8.9	N/A	Grade Break XSlope (%)	0.0
No	Ramp XSlope (%)	3.2			
N/A	Flare Type LT	N/A	N/A	Flare Type RT	N/A
N/A	Flare Slope LT (%)	N/A	N/A	Flare Slope RT (%)	0.0
N/A	Flare Traversable LT?	N/A	N/A	Flare Traversable RT?	N/A
N/A	Landing Length (in)	0.0	N/A	DWS Provided?	N/A
N/A	Landing Width (in)	0.0	N/A	DWS Contrast?	N/A
N/A	Landing Slope (%)	0.0	N/A	DWS Length (in)	N/A
N/A	Landing X Slope (%)	0.0	N/A	DWS Full Width?	N/A
N/A	Landing Curb? (Y/N)	N/A	N/A	DWS Offset LT (in)	N/A
N/A	Shared Landing?	N/A	N/A	DWS Offset RT (in)	N/A
N/A	Gutter Ponding?	0.0	N/A	Gutter Slope (%)	N/A
N/A	Gutter Lip Ht (in)	0.0	N/A	Gutter X Slope (%)	N/A
N/A	Painted X Walk1?	No		Road Slope (%)	5.3
	X Walk 1 Direction	To SE		Road X Slope (%)	6.3
	X Walk 1 Width (in)	N/A		Clear Space?	N/A

X Walk 1 Slope (%)	5.3	N/A	Clear Space to XWalk (in)	N/A
	X Walk 1 X Slope (%)	6.3	N/A	Storm Grate/Utility Hazard?	N/A
N/A	Ramp inside XWalk1?	N/A		Storm Grate/Utility Type	
N/A	Any Obstructions?	N/A			N/A
	Obstruction Type		Yes	Surface Condition? (G/P)	Good
			N/A	Curb Slope (%)	5.9

Possible Solutions:

Remove & Replace Entire Ramp.
