Access Compliance Report

Public Rights-of-Way

(Curb Ramps)

Intersection ID: 43655	Main Street: HUNTINGTON_MEADOW_LN	Cross Street: KELLINGTON_CT	Location: NE
ADA ID: E427D3B28203	Ramp Type: PerpDiag	Initial Pass/Fail: Fail	Overall Compliance: No
Codes/Mitigation Info/Possible Solution		Field Measurements/Component Compliance	
Severity Score: 21.25

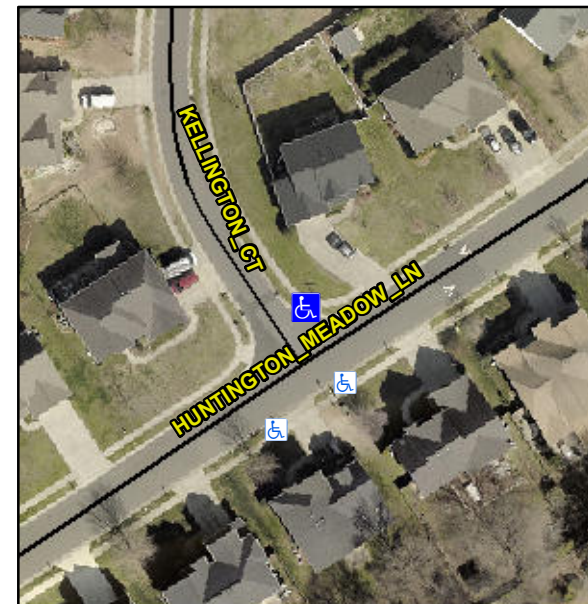
Compliance	Description	Data	Compliance	Description	Data
N/A	Ramp Length (in)	48.0	No	Ramp Slope (%)	10.2
No	Ramp Width (in)	41.0	Yes	Ramp XSlope (%)	1.0
N/A	Flare Type LT	N/A	N/A	Flare Type RT	N/A
N/A	Flare Slope LT (%)	N/A	N/A	Flare Slope RT (%)	N/A
N/A	Flare Traversable LT?	N/A	N/A	Flare Traversable RT?	N/A
N/A	Landing Length (in)	N/A	N/A	DWS Provided?	N/A
N/A	Landing Width (in)	N/A	N/A	DWS Contrast?	N/A
N/A	Landing Slope (%)	N/A	N/A	DWS Length (in)	N/A
N/A	Landing X Slope (%)	N/A	N/A	DWS Full Width?	N/A
N/A	Landing Curb? (Y/N)	N/A	N/A	DWS Offset (in)	N/A
N/A	Shared Landing?	N/A			
N/A	Gutter Ponding?	N/A	N/A	Gutter Slope (%)	N/A
N/A	Gutter Lip Ht (in)	N/A	N/A	Gutter X Slope (%)	N/A
N/A	Painted X Walk1?	No	N/A	Painted X Walk2?	No
	X Walk 1 Direction	To SW		X Walk 2 Direction	To S
N/A	X Walk 1 Width (in)	N/A	N/A	X Walk 2 Width (in)	N/A
	X Walk 1 Slope (%)	3.2		X Walk 2 Slope (%)	3.3
	X Walk 1 X Slope (%)	1.7		X Walk 2 X Slope (%)	0.6

N/A	Ramp inside XWalk1?	N/A	N/A	Ramp inside XWalk2?	N/A
	Road Slope (%)	0.2	N/A	Clear Space?	N/A
	Road X Slope (%)	3.6	N/A	Clear Space to XWalk (in)	N/A
N/A	Any Obstructions?	N/A	N/A	Storm Grate/Utility Hazard?	N/A
	Obstruction Type			Storm Grate/Utility Type	
		N/A			N/A
			Yes	Surface Condition? (G/P)	Good

Possible Solutions:

Remove & Replace Curb Ramp With Two New Directional Ramps or Equivalent.
