Access Compliance Report

Public Rights-of-Way (Curb Ramps)

Intersection ID: 15174	Main Street: DILWORTH_RD_WEST	Cross Street: IDEAL_WY	Location: NE
ADA ID: E43CB11C3A0A	Ramp Type: Directional1	Initial Pass/Fail: Fail	Overall Compliance: No
		Severity Score: 25

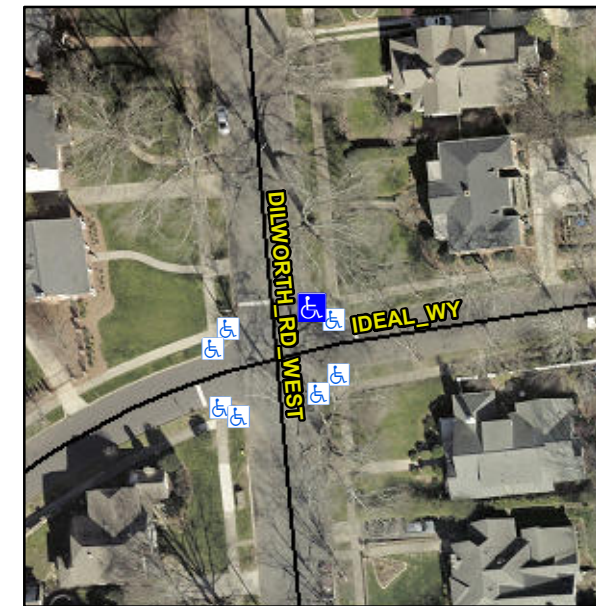
Compliance	Description	Data	Compliance	Description	Data
N/A	Ramp Length (in)	110.0	N/A	Grade Break?	N/A
Yes	Ramp Width (in)	48.0	N/A	Grade Break Slope (%)	0.0
Yes	Ramp Slope (%)	5.8	N/A	Grade Break XSlope (%)	0.0
No	Ramp XSlope (%)	7.6			
N/A	Flare Type LT	N/A	N/A	Flare Type RT	N/A
N/A	Flare Slope LT (%)	N/A	N/A	Flare Slope RT (%)	0.0
N/A	Flare Traversable LT?	N/A	N/A	Flare Traversable RT?	N/A
N/A	Landing Length (in)	0.0	N/A	DWS Provided?	N/A
N/A	Landing Width (in)	0.0	N/A	DWS Contrast?	N/A
N/A	Landing Slope (%)	0.0	N/A	DWS Length (in)	N/A
N/A	Landing X Slope (%)	0.0	N/A	DWS Full Width?	N/A
N/A	Landing Curb? (Y/N)	N/A	N/A	DWS Offset LT (in)	N/A
N/A	Shared Landing?	N/A	N/A	DWS Offset RT (in)	N/A
N/A	Gutter Ponding?	Yes	N/A	Gutter Slope (%)	N/A
N/A	Gutter Lip Ht (in)	0.0	N/A	Gutter X Slope (%)	N/A
N/A	Painted X Walk1?	No		Road Slope (%)	4.2
	X Walk 1 Direction	To SW		Road X Slope (%)	1.5
	X Walk 1 Width (in)	N/A		Clear Space?	N/A

X Walk 1 Slope (%)	4.2	N/A	Clear Space to XWalk (in)	N/A
	X Walk 1 X Slope (%)	1.5	N/A	Storm Grate/Utility Hazard?	N/A
N/A	Ramp inside XWalk1?	N/A		Storm Grate/Utility Type	
N/A	Any Obstructions?	N/A			N/A
	Obstruction Type		Yes	Surface Condition? (G/P)	Good
			N/A	Curb Slope (%)	5.8

Remove & Replace Entire Ramp.

R304.5.3

\$ 1600.00
