Access Compliance Report

Public Rights-of-Way

(Curb Ramps)

Intersection ID: 13369	Main Street: N_I-77_RA	Cross Street: WEST_BV	Location: S
ADA ID: E4456F21DAA6	Ramp Type: Para	Initial Pass/Fail: Fail	Overall Compliance: No
		Severity Score: 35

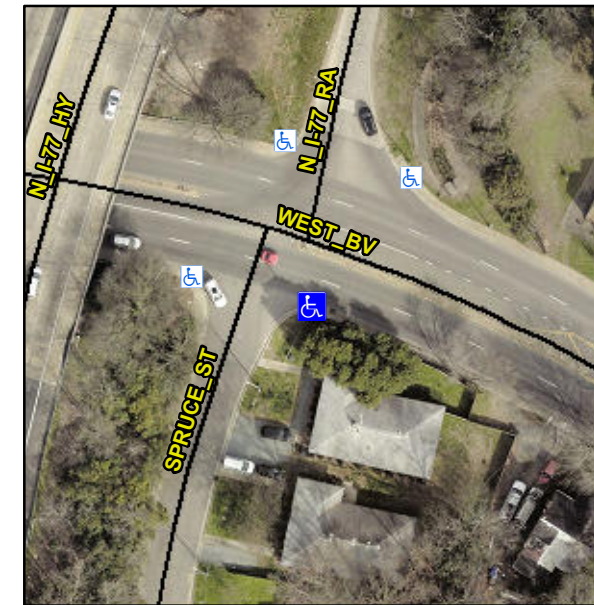
R304.5.1, R304.3.2, R304.5.3

Compliance	Description	Data	Compliance	Description	Data
N/A	Ramp Length LT (in)	50.0	N/A	Ramp Length RT (in)	N/A
No	Ramp Width LT (in)	42.0	N/A	Ramp Width RT (in)	N/A
No	Ramp Slope LT (%)	15.0	N/A	Ramp Slope RT (%)	N/A
No	Ramp XSlope LT (%)	4.4	N/A	Ramp XSlope RT (%)	N/A
N/A	Landing Length (in)	N/A	N/A	DWS Provided?	N/A
N/A	Landing Width (in)	N/A	N/A	DWS Contrast?	N/A
N/A	Landing Slope (%)	N/A	N/A	DWS Length (in)	N/A
N/A	Landing X Slope (%)	N/A	N/A	DWS Full Width?	N/A
N/A	Landing Curb? (Y/N)	N/A	N/A	DWS Offset (in)	N/A
N/A	Shared Landing?	N/A			
N/A	Gutter Ponding?	N/A	N/A	Gutter Slope (%)	N/A
N/A	Gutter Lip Ht (in)	N/A	N/A	Gutter X Slope (%)	N/A
N/A	Painted X Walk1?	No	N/A	Painted X Walk2?	N/A
	X Walk 1 Direction	To NW		X Walk 2 Direction	N/A
N/A	X Walk 1 Width (in)	N/A	N/A	X Walk 2 Width (in)	N/A
	X Walk 1 Slope (%)	0.9		X Walk 2 Slope (%)	N/A
	X Walk 1 X Slope (%)	2.7		X Walk 2 X Slope (%)	N/A
N/A	Ramp inside XWalk1?	N/A	N/A	Ramp inside XWalk2?	N/A

Road Slope (%)	N/A	N/A	Clear Space?	N/A
	Road X Slope (%)	N/A	N/A	Clear Space to XWalk (in)	N/A
N/A	Any Obstructions?	N/A	N/A	Storm Grate/Utility Hazard?	N/A
	Obstruction Type			Storm Grate/Utility Type	
		N/A			N/A
			Yes	Surface Condition? (G/P)	Good
			N/A	Curb Slope (%)	3.1

Remove & Replace Entire Ramp.

Total Cost: \$ 1600.00
