Access Compliance Report

Public Rights-of-Way

(Curb Ramps)

Intersection ID: 15435	Main Street: LATTIMORE_ST	Cross Street: SCOTT_AV	Location: S
ADA ID: E44FEA639423	Ramp Type: Directional1	Initial Pass/Fail: Fail	Overall Compliance: No
Severity Score: 33.75			
Codes/Mitigation Info/Possible Solution		Field Measurements/Component Compliance

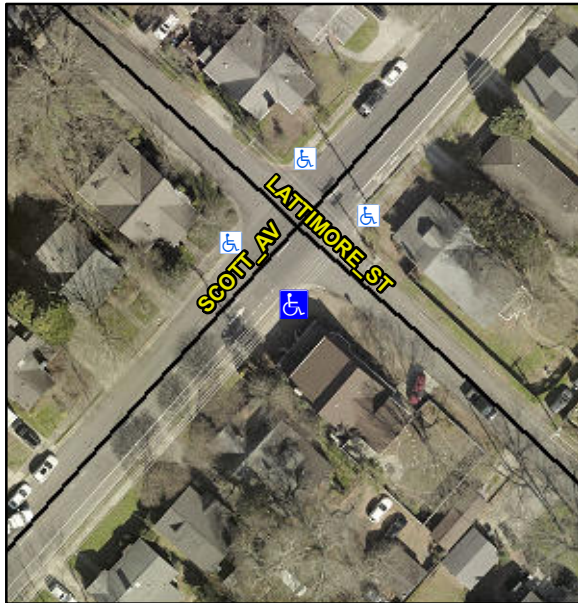
R304.5.1, R304.2.2

Compliance	Description	Data	Compliance	Description	Data
N/A	Ramp Length (in)	43.0	N/A	Grade Break?	N/A
No	Ramp Width (in)	38.0	N/A	Grade Break Slope (%)	0.0
No	Ramp Slope (%)	13.8	N/A	Grade Break XSlope (%)	0.0
Yes	Ramp XSlope (%)	1.5			
N/A	Flare Type LT	N/A	N/A	Flare Type RT	N/A
N/A	Flare Slope LT (%)	N/A	N/A	Flare Slope RT (%)	0.0
N/A	Flare Traversable LT?	N/A	N/A	Flare Traversable RT?	N/A
N/A	Landing Length (in)	0.0	N/A	DWS Provided?	N/A
N/A	Landing Width (in)	0.0	N/A	DWS Contrast?	N/A
N/A	Landing Slope (%)	0.0	N/A	DWS Length (in)	N/A
N/A	Landing X Slope (%)	0.0	N/A	DWS Full Width?	N/A
N/A	Landing Curb? (Y/N)	N/A	N/A	DWS Offset LT (in)	N/A
N/A	Shared Landing?	N/A	N/A	DWS Offset RT (in)	N/A
N/A	Gutter Ponding?	0.0	N/A	Gutter Slope (%)	N/A
N/A	Gutter Lip Ht (in)	0.0	N/A	Gutter X Slope (%)	N/A
N/A	Painted X Walk1?	No		Road Slope (%)	1.8
	X Walk 1 Direction	To NE		Road X Slope (%)	4.3
	X Walk 1 Width (in)	N/A		Clear Space?	N/A

X Walk 1 Slope (%)	1.8	N/A	Clear Space to XWalk (in)	N/A
	X Walk 1 X Slope (%)	4.3	N/A	Storm Grate/Utility Hazard?	N/A
N/A	Ramp inside XWalk1?	N/A		Storm Grate/Utility Type	
N/A	Any Obstructions?	N/A			N/A
	Obstruction Type		Yes	Surface Condition? (G/P)	Good
			N/A	Curb Slope (%)	15.1

Remove & Replace Entire Ramp.
