Access Compliance Report

Public Rights-of-Way

(Curb Ramps)

Intersection ID: 10399	Main Street: E_35TH_ST	Cross Street: GARRISON_ST	Location: S
ADA ID: E450A51F6B3D	Ramp Type: Perp	Initial Pass/Fail: Fail	Overall Compliance: No
Severity Score: 25			
Codes/Mitigation Info/Possible Solution		Field Measurements/Component Compliance

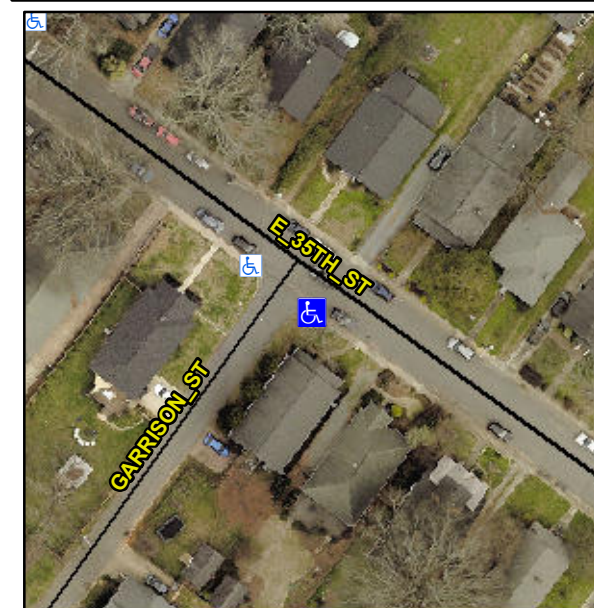
Not Found, R304.2.2

Compliance	Description	Data	Compliance	Description	Data
N/A	Ramp Length (in)	30.5	No	Ramp Slope (%)	12.0
Yes	Ramp Width (in)	48.0	Yes	Ramp XSlope (%)	0.5
N/A	Flare Type LT	N/A	N/A	Flare Type RT	N/A
N/A	Flare Slope LT (%)	N/A	N/A	Flare Slope RT (%)	N/A
N/A	Flare Traversable LT?	N/A	N/A	Flare Traversable RT?	N/A
N/A	Landing Length (in)	N/A	N/A	DWS Provided?	N/A
N/A	Landing Width (in)	N/A	N/A	DWS Contrast?	N/A
N/A	Landing Slope (%)	N/A	N/A	DWS Length (in)	N/A
N/A	Landing X Slope (%)	N/A	N/A	DWS Full Width?	N/A
N/A	Landing Curb? (Y/N)	N/A	N/A	DWS Offset (in)	N/A
N/A	Shared Landing?	N/A			
N/A	Gutter Ponding?	N/A	N/A	Gutter Slope (%)	N/A
N/A	Gutter Lip Ht (in)	1.0	N/A	Gutter X Slope (%)	N/A
N/A	Painted X Walk1?	No	N/A	Painted X Walk2?	N/A
	X Walk 1 Direction	To NW		X Walk 2 Direction	N/A
N/A	X Walk 1 Width (in)	N/A	N/A	X Walk 2 Width (in)	N/A
	X Walk 1 Slope (%)	0.7		X Walk 2 Slope (%)	N/A
	X Walk 1 X Slope (%)	7.2		X Walk 2 X Slope (%)	N/A

N/A	Ramp inside XWalk1?	N/A	N/A	Ramp inside XWalk2?	N/A
	Road Slope (%)	N/A	N/A	Clear Space?	N/A
	Road X Slope (%)	N/A	N/A	Clear Space to XWalk (in)	N/A
N/A	Any Obstructions?	N/A	N/A	Storm Grate/Utility Hazard?	N/A
	Obstruction Type			Storm Grate/Utility Type	
		N/A			N/A
			Yes	Surface Condition? (G/P)	Good

Possible Solutions:

Remove & Replace Entire Ramp.

Total Cost: \$ 1850.00
