Access Compliance Report

Public Rights-of-Way

(Curb Ramps)

Intersection ID: 3126	Main Street: BROWNESTONE_VIEW_DR	Cross Street: GALENA_VIEW_DR	Location: W
ADA ID: E452214C2F18	Ramp Type: Perp	Initial Pass/Fail: Fail	Overall Compliance: No
Severity Score: 12.5			
Codes/Mitigation Info/Possible Solution		Field Measurements/Component Compliance

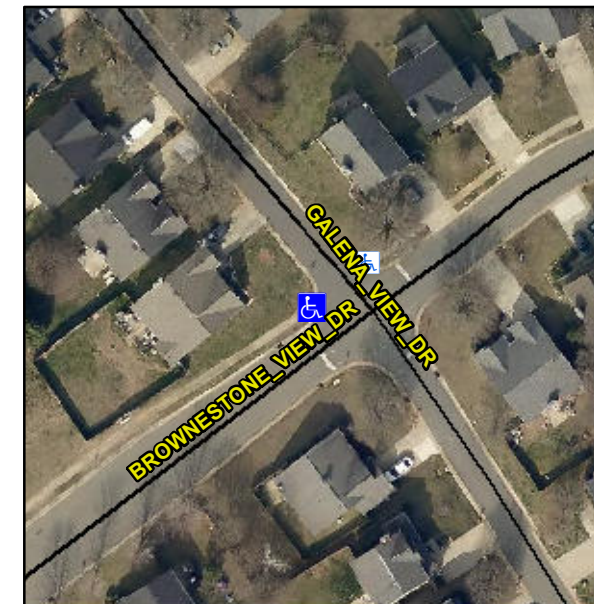
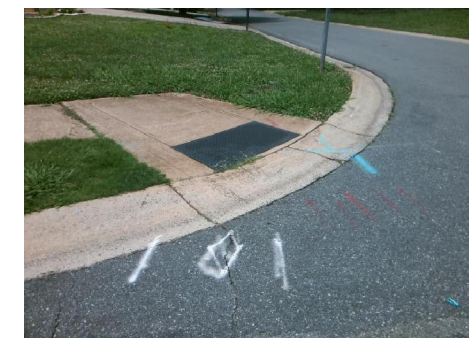
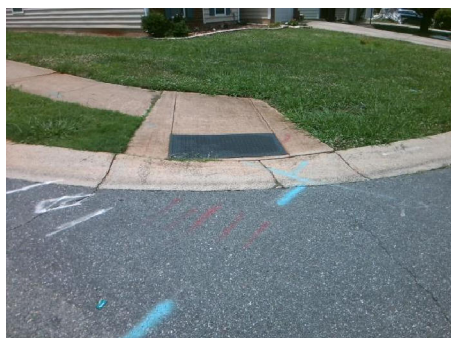
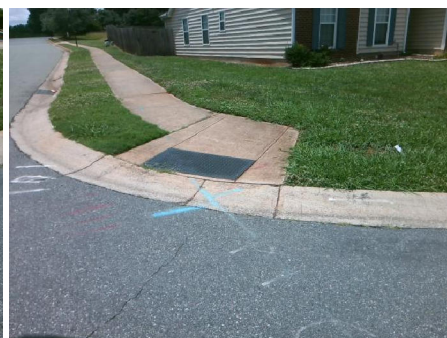
Not Found, R304.5.3

Compliance	Description	Data	Compliance	Description	Data
N/A	Ramp Length (in)	94.0	Yes	Ramp Slope (%)	5.0
Yes	Ramp Width (in)	48.0	No	Ramp XSlope (%)	5.9
N/A	Flare Type LT	N/A	N/A	Flare Type RT	N/A
N/A	Flare Slope LT (%)	N/A	N/A	Flare Slope RT (%)	N/A
N/A	Flare Traversable LT?	N/A	N/A	Flare Traversable RT?	N/A
N/A	Landing Length (in)	N/A	N/A	DWS Provided?	N/A
N/A	Landing Width (in)	N/A	N/A	DWS Contrast?	N/A
N/A	Landing Slope (%)	N/A	N/A	DWS Length (in)	N/A
N/A	Landing X Slope (%)	N/A	N/A	DWS Full Width?	N/A
N/A	Landing Curb? (Y/N)	N/A	N/A	DWS Offset (in)	N/A
N/A	Shared Landing?	N/A			
N/A	Gutter Ponding?	N/A	N/A	Gutter Slope (%)	N/A
N/A	Gutter Lip Ht (in)	N/A	N/A	Gutter X Slope (%)	N/A
N/A	Painted X Walk1?	No	N/A	Painted X Walk2?	N/A
	X Walk 1 Direction	To NE		X Walk 2 Direction	N/A
N/A	X Walk 1 Width (in)	N/A	N/A	X Walk 2 Width (in)	N/A
	X Walk 1 Slope (%)	0.3		X Walk 2 Slope (%)	N/A
	X Walk 1 X Slope (%)	5.0		X Walk 2 X Slope (%)	N/A

N/A	Ramp inside XWalk1?	N/A	N/A	Ramp inside XWalk2?	N/A
	Road Slope (%)	N/A	N/A	Clear Space?	N/A
	Road X Slope (%)	N/A	N/A	Clear Space to XWalk (in)	N/A
N/A	Any Obstructions?	N/A	N/A	Storm Grate/Utility Hazard?	N/A
	Obstruction Type			Storm Grate/Utility Type	
		N/A			N/A
			Yes	Surface Condition? (G/P)	Good

Remove & Replace Entire Ramp.
