## **Access Compliance Report Public Rights-of-Way** (Curb Ramps)

Intersection ID: 10033476 Main Street: OLD PINEVILLE RD **Cross Street: BARTON BV** Location: NW ADA ID: E46A879EF861 Ramp Type: Directional1 Initial Pass/Fail: Fail **Overall Compliance: No Severity Score:** 12.5

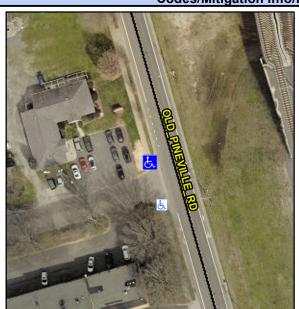
N/A	Ramp Length (in)	120.0	N/A	Grade Break?	N/A
Yes	Ramp Width (in)	69.5	N/A	Grade Break Slope (%)	0.0
Yes	Ramp Slope (%)	4.0	N/A	Grade Break XSlope (%)	0.0
No	Ramp XSlope (%)	5.1			
N/A	Flare Type LT	N/A	N/A	Flare Type RT	N/A
N/A	Flare Slope LT (%)	N/A	N/A	Flare Slope RT (%)	0.0
N/A	Flare Traversable LT?	N/A	N/A	Flare Traversable RT?	N/A
N/A	Landing Length (in)	0.0	N/A	DWS Provided?	N/A
N/A	Landing Width (in)	0.0	N/A	DWS Contrast?	N/A
N/A	Landing Slope (%)	0.0	N/A	DWS Length (in)	N/A
N/A	Landing X Slope (%)	0.0	N/A	DWS Full Width?	N/A
N/A	Landing Curb? (Y/N)	N/A	N/A	DWS Offset LT (in)	N/A
N/A	Shared Landing?	N/A	N/A	DWS Offset RT (in)	N/A
N/A	Gutter Ponding?	0.0	N/A	Gutter Slope (%)	N/A
N/A	Gutter Lip Ht (in)	0.0	N/A	Gutter X Slope (%)	N/A
N/A	Painted X Walk1?	No		Road Slope (%)	8.0
	X Walk 1 Direction	To S		Road X Slope (%)	4.7
	X Walk 1 Width (in)	N/A		Clear Space?	N/A
	X Walk 1 Slope (%)	0.8	N/A	Clear Space to XWalk (in)	N/A

X Walk 1 X Slope (%)	4.7	N/A	Storm Grate/Utility Hazard?	N/A
N/A	Ramp inside XWalk1?	N/A		Storm Grate/Utility Type	
N/A	Any Obstructions?	N/A			N/A
	Obstruction Type		Yes	Surface Condition? (G/P)	Good
		N/A	N/A	Curb Slope (%)	17.0

Possible Solutions:							
Remove & Replace Entire Ramp.							
Surveyor Notes:							
N/A							
PROMIAR A							
PROW/ADA:							
R304.5.3
