Access Compliance Report

Public Rights-of-Way

(Curb Ramps)

Intersection ID: 3474	Main Street: W W T HARRIS BV	Cross Street: W WT HARRIS TO I-77 RA NB	Location: S
ADA ID: E46C18AAB881	Ramp Type: Para	Initial Pass/Fail: Fail	Overall Compliance: No
Codes/Mitigation Info/Possible Solution		Field Measurements/Component Compliance

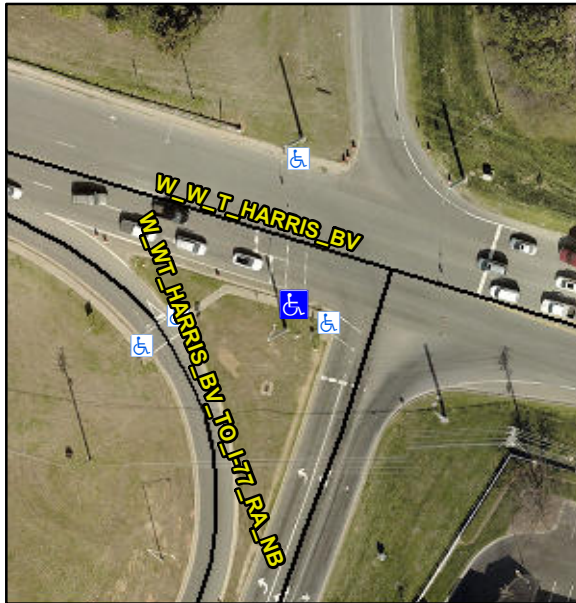
PROW/ADA:

R304.5.3, R304.3.2

Compliance	Description	Data	Compliance	Description	Data
N/A	Ramp Length LT (in)	68.5	N/A	Ramp Length RT (in)	66.5
Yes	Ramp Width LT (in)	59.5	Yes	Ramp Width RT (in)	59.0
Yes	Ramp Slope LT (%)	6.5	No	Ramp Slope RT (%)	9.7
No	Ramp XSlope LT (%)	2.8	Yes	Ramp XSlope RT (%)	2.0
N/A	Landing Length (in)	N/A	N/A	DWS Provided?	N/A
N/A	Landing Width (in)	N/A	N/A	DWS Contrast?	N/A
N/A	Landing Slope (%)	N/A	N/A	DWS Length (in)	N/A
N/A	Landing X Slope (%)	N/A	N/A	DWS Full Width?	N/A
N/A	Landing Curb? (Y/N)	N/A	N/A	DWS Offset (in)	N/A
N/A	Shared Landing?	N/A			
N/A	Gutter Ponding?	N/A	N/A	Gutter Slope (%)	N/A
N/A	Gutter Lip Ht (in)	N/A	N/A	Gutter X Slope (%)	N/A
N/A	Painted X Walk1?	No	N/A	Painted X Walk2?	N/A
	X Walk 1 Direction	To N		X Walk 2 Direction	N/A
N/A	X Walk 1 Width (in)	N/A	N/A	X Walk 2 Width (in)	N/A
	X Walk 1 Slope (%)	4.0		X Walk 2 Slope (%)	N/A
	X Walk 1 X Slope (%)	0.8		X Walk 2 X Slope (%)	N/A
N/A	Ramp inside XWalk1?	N/A	N/A	Ramp inside XWalk2?	N/A

Road Slope (%)	N/A	N/A	Clear Space?	N/A
	Road X Slope (%)	N/A	N/A	Clear Space to XWalk (in)	N/A
N/A	Any Obstructions?	N/A	N/A	Storm Grate/Utility Hazard?	N/A
	Obstruction Type			Storm Grate/Utility Type	
		N/A			N/A
			Yes	Surface Condition? (G/P)	Good
			N/A	Curb Slope (%)	N/A

Possible Solutions:

Remove & Replace Entire Ramp.
