Access Compliance Report Public Rights-of-Way (Curb Ramps)

Cross Street: PARK RD Intersection ID: 19006 Main Street: CORTLAND RD Location: SW Initial Pass/Fail: Fail **Overall Compliance: No Severity Score:** 25 ADA ID: E46C8796789A Ramp Type: Perp

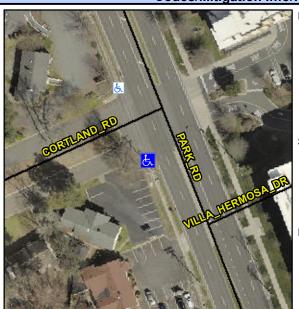
Compliance Description Data Compliance Description Yes N/A Ramp Length (in) 39.0 No Yes Ramp Width (in) 48.0 N/A Flare Type LT N/A N/A N/A N/A N/A Flare Slope LT (%) N/A Flare Traversable LT? N/A N/A N/A N/A N/A Landing Length (in) N/A Landing Width (in) N/A N/A N/A N/A N/A Landing Slope (%) N/A Landing X Slope (%) N/A N/A N/A Landing Curb? (Y/N) N/A N/A N/A N/A Shared Landing? N/A **Gutter Ponding?** N/A N/A N/A Gutter Lip Ht (in) N/A N/A N/A Painted X Walk1? No N/A X Walk 1 Direction To N N/A N/A X Walk 1 Width (in) X Walk 1 Slope (%) 4.0 X Walk 1 X Slope (%) 0.6 N/A N/A N/A Ramp inside XWalk1? Road Slope (%) N/A N/A N/A Road X Slope (%) N/A N/A Any Obstructions? N/A

Possible Solutions: Remove & Replace Entire Ramp. Surveyor Notes: N/A PROW/ADA: Not Found, R304.5.3
