## Access Compliance Report Public Rights-of-Way (Curb Ramps)

Intersection ID: 8373 Main Street: AUGUSTA\_ST Cross Street: LASALLE\_ST Location: NE

ADA ID: E46D26022FAF Ramp Type: PerpDiag Initial Pass/Fail: Fail Overall Compliance: No Severity Score: 33.75

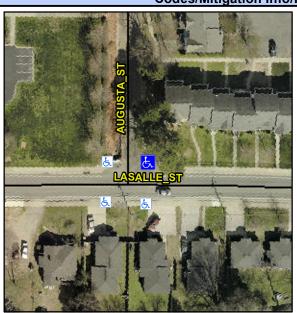
PROW/ADA:
Not Found, R304.5.1, R304.2.2

Compliance Description Data Compliance Description Data No N/A Ramp Length (in) 60.0 Ramp Slope (%) 14.9 Ramp XSlope (%) No Ramp Width (in) 39.0 Yes 0.7 N/A N/A Flare Type LT N/A Flare Type RT N/A N/A N/A N/A Flare Slope RT (%) N/A Flare Slope LT (%) N/A Flare Traversable LT? N/A N/A Flare Traversable RT? N/A N/A N/A N/A **DWS Provided?** N/A Landing Length (in) N/A Landing Width (in) N/A N/A **DWS Contrast?** N/A N/A N/A N/A Landing Slope (%) DWS Length (in) N/A N/A Landing X Slope (%) N/A N/A DWS Full Width? N/A N/A Landing Curb? (Y/N) N/A N/A DWS Offset (in) N/A N/A N/A Shared Landing? N/A **Gutter Ponding?** N/A N/A Gutter Slope (%) N/A N/A Gutter Lip Ht (in) 1.5 N/A Gutter X Slope (%) N/A N/A Painted X Walk1? No N/A Painted X Walk2? No X Walk 1 Direction To W X Walk 2 Direction To S N/A N/A X Walk 1 Width (in) N/A X Walk 2 Width (in) N/A X Walk 1 Slope (%) 1.7 X Walk 2 Slope (%) 1.4 X Walk 1 X Slope (%) 0.5 X Walk 2 X Slope (%) 0.4 N/A N/A N/A Ramp inside XWalk2? Ramp inside XWalk1? N/A Road Slope (%) 1.5 N/A Clear Space? N/A N/A Road X Slope (%) Clear Space to XWalk (in) N/A 1.4 N/A N/A Any Obstructions? N/A Storm Grate/Utility Hazard? N/A **Obstruction Type** Storm Grate/Utility Type N/A N/A

Remove & Replace Curb Ramp With
Two New Directional Ramps or
Equivalent.
