Access Compliance Report

Public Rights-of-Way

(Curb Ramps)

Intersection ID: 53745	Main Street: SPRINGWOOD_ESTATE_DR	Cross Street: CANTERBURY_CASTLE_DR	Location: NW
ADA ID: E4716D421475	Ramp Type: Perp	Initial Pass/Fail: Fail	Overall Compliance: No
Severity Score: 12.5			
Codes/Mitigation Info/Possible Solution		Field Measurements/Component Compliance

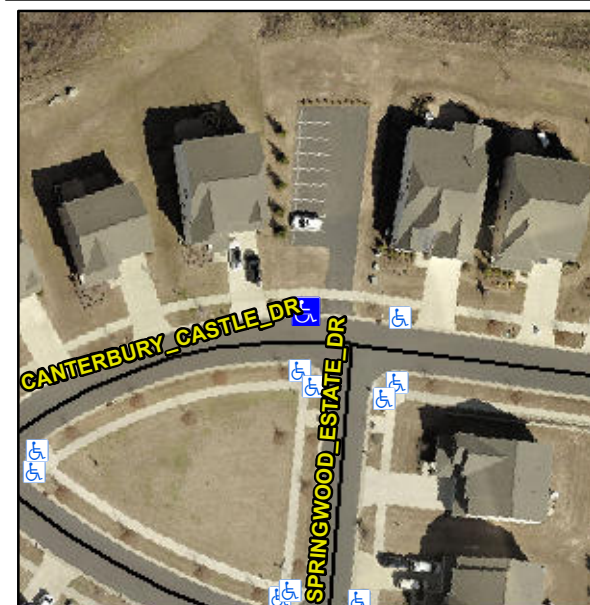
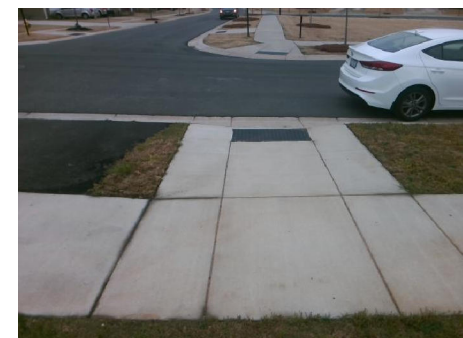
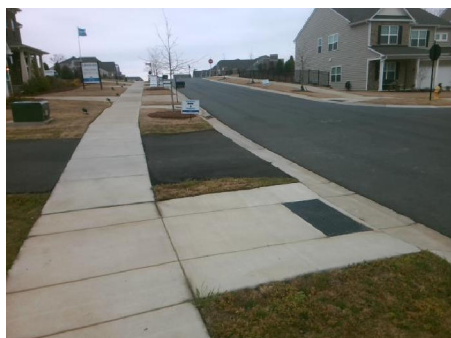
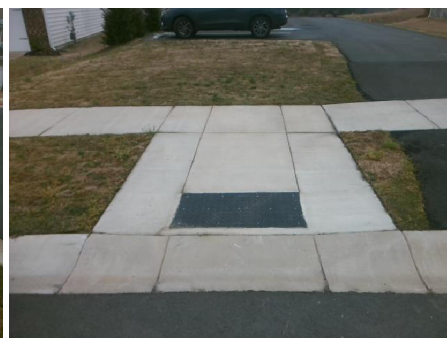
Not Found, R304.5.3

Compliance	Description	Data	Compliance	Description	Data
N/A	Ramp Length (in)	96.0	Yes	Ramp Slope (%)	5.2
Yes	Ramp Width (in)	48.0	No	Ramp XSlope (%)	5.3
N/A	Flare Type LT	N/A	N/A	Flare Type RT	N/A
N/A	Flare Slope LT (%)	N/A	N/A	Flare Slope RT (%)	N/A
N/A	Flare Traversable LT?	N/A	N/A	Flare Traversable RT?	N/A
N/A	Landing Length (in)	N/A	N/A	DWS Provided?	N/A
N/A	Landing Width (in)	N/A	N/A	DWS Contrast?	N/A
N/A	Landing Slope (%)	N/A	N/A	DWS Length (in)	N/A
N/A	Landing X Slope (%)	N/A	N/A	DWS Full Width?	N/A
N/A	Landing Curb? (Y/N)	N/A	N/A	DWS Offset (in)	N/A
N/A	Shared Landing?	N/A			
N/A	Gutter Ponding?	N/A	N/A	Gutter Slope (%)	N/A
N/A	Gutter Lip Ht (in)	N/A	N/A	Gutter X Slope (%)	N/A
N/A	Painted X Walk1?	No	N/A	Painted X Walk2?	N/A
	X Walk 1 Direction	To SW		X Walk 2 Direction	N/A
N/A	X Walk 1 Width (in)	N/A	N/A	X Walk 2 Width (in)	N/A
	X Walk 1 Slope (%)	1.7		X Walk 2 Slope (%)	N/A
	X Walk 1 X Slope (%)	4.6		X Walk 2 X Slope (%)	N/A

Possible Solutions:

Remove & Replace Entire Ramp.
