# Access Compliance Report

## Public Rights-of-Way

### (Curb Ramps)

Intersection ID: 13407	Main Street: PARK_HICKORY_DR	Cross Street: TRYSTING_RD	Location: NW
ADA ID: E47CE49CE5F3	Ramp Type: PerpDiag	Initial Pass/Fail: Fail	Overall Compliance: No
Codes/Mitigation Info/Possible Solution		Field Measurements/Component Compliance	
Severity Score: 8.75

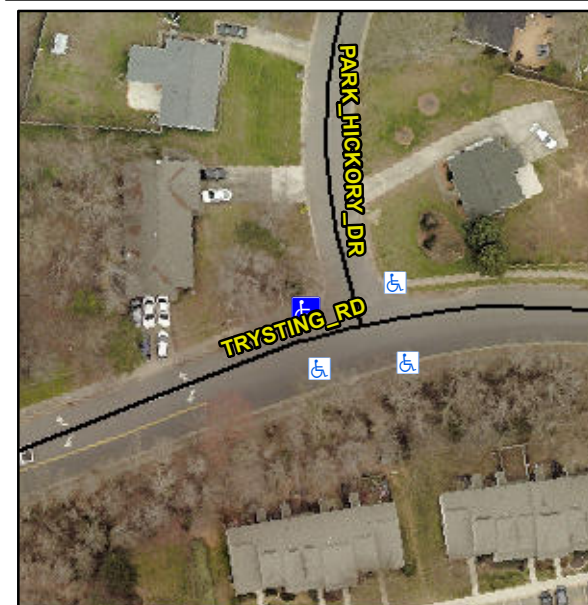
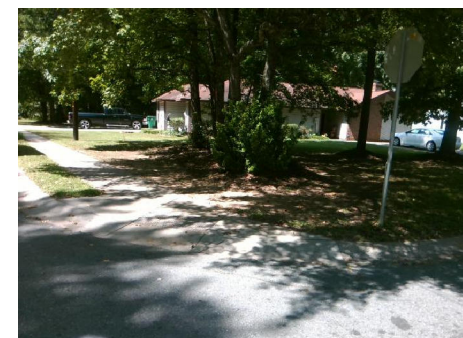
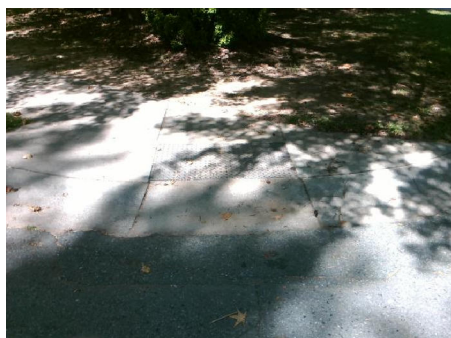
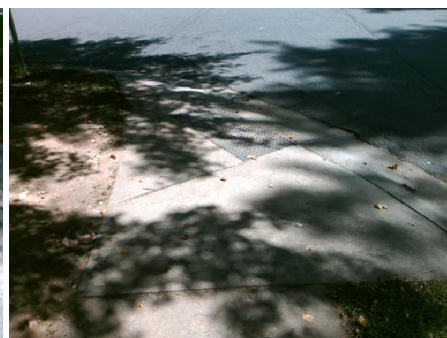
**Not Found, R304.5.1**

Compliance	Description	Data	Compliance	Description	Data
N/A	Ramp Length (in)	44.0	Yes	Ramp Slope (%)	5.7
No	Ramp Width (in)	47.5	Yes	Ramp XSlope (%)	0.5
N/A	Flare Type LT	N/A	N/A	Flare Type RT	N/A
N/A	Flare Slope LT (%)	N/A	N/A	Flare Slope RT (%)	N/A
N/A	Flare Traversable LT?	N/A	N/A	Flare Traversable RT?	N/A
N/A	Landing Length (in)	N/A	N/A	DWS Provided?	N/A
N/A	Landing Width (in)	N/A	N/A	DWS Contrast?	N/A
N/A	Landing Slope (%)	N/A	N/A	DWS Length (in)	N/A
N/A	Landing X Slope (%)	N/A	N/A	DWS Full Width?	N/A
N/A	Landing Curb? (Y/N)	N/A	N/A	DWS Offset (in)	N/A
N/A	Shared Landing?	N/A			
N/A	Gutter Ponding?	N/A	N/A	Gutter Slope (%)	N/A
N/A	Gutter Lip Ht (in)	N/A	N/A	Gutter X Slope (%)	N/A
N/A	Painted X Walk1?	No	N/A	Painted X Walk2?	No
	X Walk 1 Direction	To S		X Walk 2 Direction	To E
N/A	X Walk 1 Width (in)	N/A	N/A	X Walk 2 Width (in)	N/A
	X Walk 1 Slope (%)	5.4		X Walk 2 Slope (%)	3.9
	X Walk 1 X Slope (%)	1.7		X Walk 2 X Slope (%)	2.9

N/A	Ramp inside XWalk1?	N/A	N/A	Ramp inside XWalk2?	N/A
	Road Slope (%)	0.5	N/A	Clear Space?	N/A
	Road X Slope (%)	6.3	N/A	Clear Space to XWalk (in)	N/A
N/A	Any Obstructions?	N/A	N/A	Storm Grate/Utility Hazard?	N/A
	Obstruction Type			Storm Grate/Utility Type	
		N/A			N/A
			Yes	Surface Condition? (G/P)	Good

**Remove & Replace Curb Ramp With Two New Directional Ramps or Equivalent.**
